Assessment of Bond Strength of Various Cementitious Sealants for CCS Well Applications

ABSTRACT

The bond performance of a range of cementitious sealants that are intended for use in the plugging of CO₂ storage wells (repurposed from sub-sea oilwells) is presented. To this end, a bespoke sample comprising a cementitious plug encapsulated in steel tube casing was designed to facilitate an enhanced curing of sealants at high pressure and temperature representing the conditions in a carbon capture and storage (CCS) well. The bond properties of the sealants following the enhanced curing regime were then examined using a relatively simple push-out-type bond testing protocol, with tests undertaken under elevated temperature and atmospheric pressure. In this article, a series of test results are presented, alongside the conditions of the sealant/steel-casing interface to provide an insight into the underlying mechanisms of the bond performance.

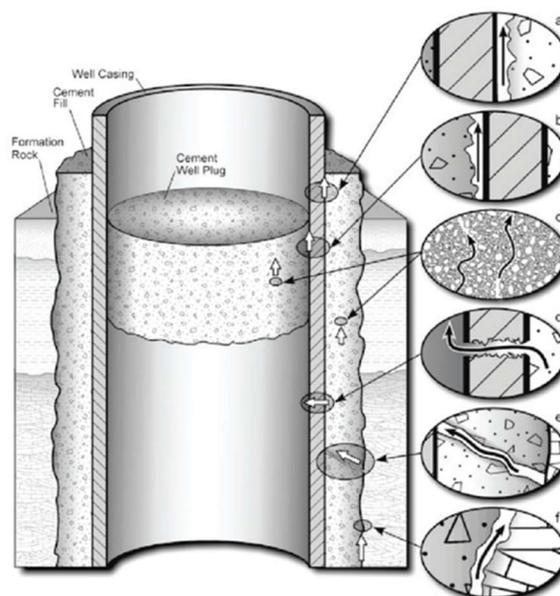
Fig.1. Schematic representation of a plugged well, showing potential leakage pathways (Gasda *et al*, 2004).

According to OEUK, over half of 280+ oil and gas fields in the North Sea of UK will cease their oil production by 2030 (upstream, 2023). With the increasing importance of the Net Zero agenda, there is a plan to repurpose some of these wells for the storage of CO₂, as part of Carbon Capture and Storage (CCS) operations. The use of cementitious materials is ideal in this regard due to their versatility for plugging and well-cementing in general. However, there is a concern regarding the potential of CO₂ leakage that might occur. The situation is exacerbated by the fact that the operational life for CCS well is expected to be much longer than an oil-well. **Figure 1** displays a schematic of a plugged wellbore with the potential leakage paths of liquid or dissolved carbon dioxide highlighted (Gasda *et al*, 2004). These can include (i) the external casing/sealant interface; (ii) the internal casing/sealant interface; (iii) the sealant body microstructure; (iv) fractured casing; (v) fractured sealant, and (vi) the external sealant/rock interface.

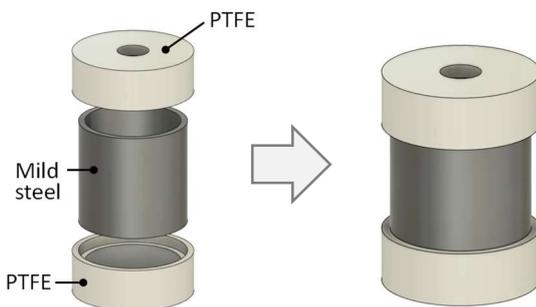
Experimental samples take the form of relatively small steel cylinders (50.8mm OD, 44mm ID, 50mm length) into which is moulded a sealant cylinder with 40mm diameter ends protruding 10mm (see **Figure 2**). The moulded shape is facilitated by two PTFE end caps which encapsulate the material during curing. Such samples are miniature versions of the sealant-plug/casing well-head represented in **Figure 1**. At the onset of the project, the use of mild steel casing instead of super duplex steel was sought by the project consortium to allow for possible occurrence of corrosion to take place, as well as to facilitate fabrication.

Fig. 2. Schematic diagram of sample holder.

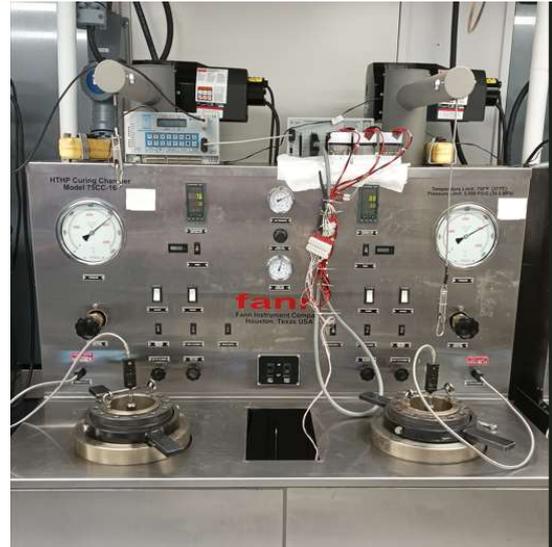
All samples were prepared and cured at the Haliburton facility in Stavanger, Norway, where autoclave equipment capable of the required enhanced curing regime is located (see **Figure 3**).

Fig. 3. Autoclaved chamber used for high temperature and high-pressure curing.

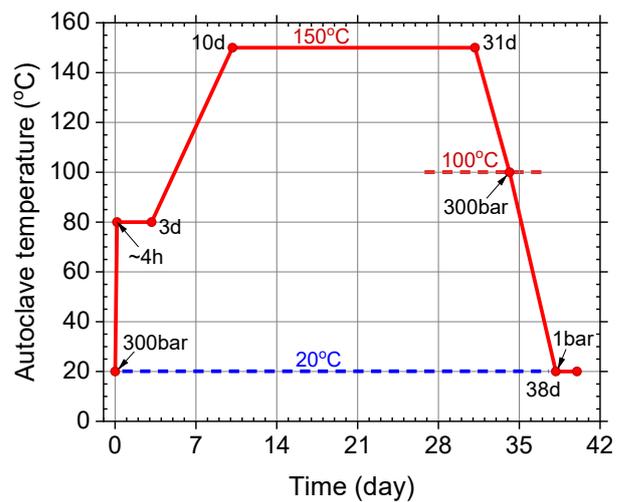
Once the material is gauged and sealed in the moulds, these are then placed in the autoclave chambers. The curing regime is summarised graphically in **Figure 4**. Initially, the autoclave system was pressurised to 300 bars. The internal temperature was then raised over a period of 4 hours to 80°C where it was held for 3 days. The temperature was then raised from 80°C to 150°C over 7 days and held at 150°C for a further 21 days. From 31.33 days, the temperature was lowered steadily from 150°C to 20°C over a period of 7 days. When the temperature reached 100°C, the internal pressure regulator was released, allowing for the chambers to reach equilibrium depending on the temperature level. The samples were removed from the autoclave after 38.33 days once they have stabilised at 20°C.

Fig. 4. Graphical summary of curing regime.

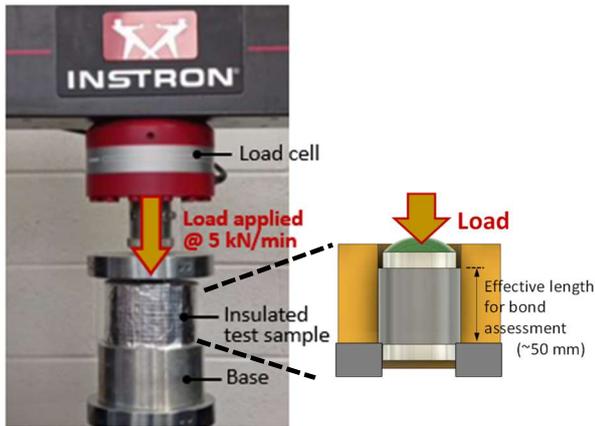
Once thoroughly cured, all samples were sent to Heriot-Watt University by air for bond testing. One day prior to testing, all sealant samples were pre-conditioned in an environmental chamber, with the temperature raised slowly to 80°C. Each sample was then immediately wrapped with an insulation, to maintain the sample temperature during testing, and tested using a 100kN universal Instron machine, following the procedure outlined in the 'Bond Strength Testing' Patent No. NO

20191422 (EP 3 832 290 A1). During testing, the load was applied on top in a load control manner, with a loading rate of 5kN/min. Testing was terminated once the plug had slid out from the steel casing.

Fig. 5. Schematic of bond testing.

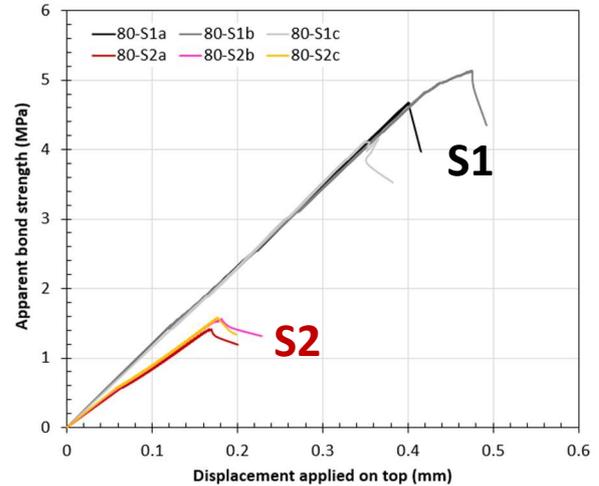
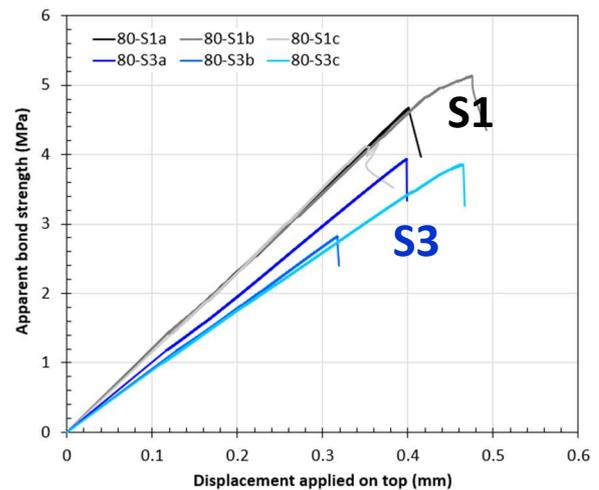
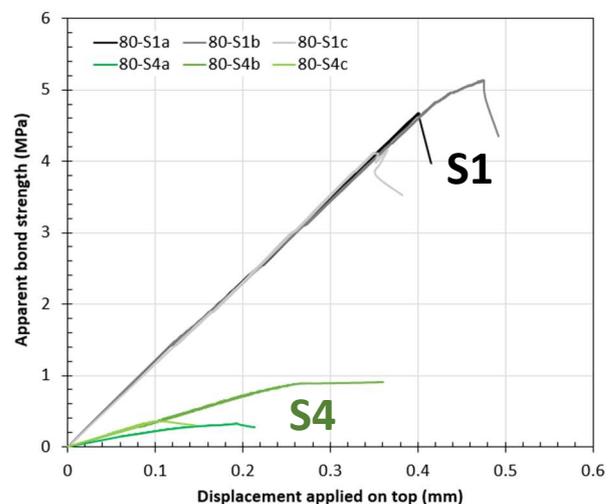
The results from the bond testing are presented in **Figure 6** in a series of Figures, representing the results obtained from individual sealants plotted on the reference sealant (S1). In this Figure, the apparent bond strength was obtained by simply dividing the load applied on top with the contact area and plotted against the displacement measured on the top of the sample. In general terms, all sealants display a similar general increase in the Apparent Bond Strength with increasing displacement as one would expect, but the individual sealant exhibits varying strengths and stiffnesses with a general reduction in the overall stiffness and bond strength evident compared to Sealant S1. For instance, in case of Sealant S2, the average mean bond strength was 1.5MPa, which is only ~33% of that of Sealant S1 (= 4.7MPa). Sealant S3 exhibited higher average bond strength, giving an average value of 3.5MPa or 76% of that of the reference value. Sealant S4 exhibited the lowest apparent bond strength, with an average value of 0.5MPa which is only approximately 11% of that of the reference sealant. This sealant also exhibited the lowest initial stiffness, indicating possibly the occurrence of slippage during testing. The higher apparent bond strength and stiffness of Sealant S1 were however found to be associated with the corrosion that developed at the sealant/casing interface. This is discussed below.

Fig. 6. Apparent bond strength vs displacement plots for various sealants.

From the investigation of four cementitious sealant materials presented in this study, wide differences in the apparent bond strength between the sealants were observed.

Sealant S1, representing material which is commonly used in well cementing, displayed the highest apparent bond strength and stiffness. It was found that the apparent bond strength and stiffness are however influenced by several different factors at the sample/steel interface, with corrosion at the casing/sealant interface appearing to be one significant factor. The elevated, apparent bond strength must therefore be treated with cautious as it might not be related to seal ability, due to corrosion contribution.

Sealant S4 had the lowest apparent bond strength, possibly due to the rapid initial hydration of this particular sealant (which is confirmed by the monitoring during the early curing, presented in a parallel article). This test is currently being repeated with the use of retarding agent to confirm this initial finding.

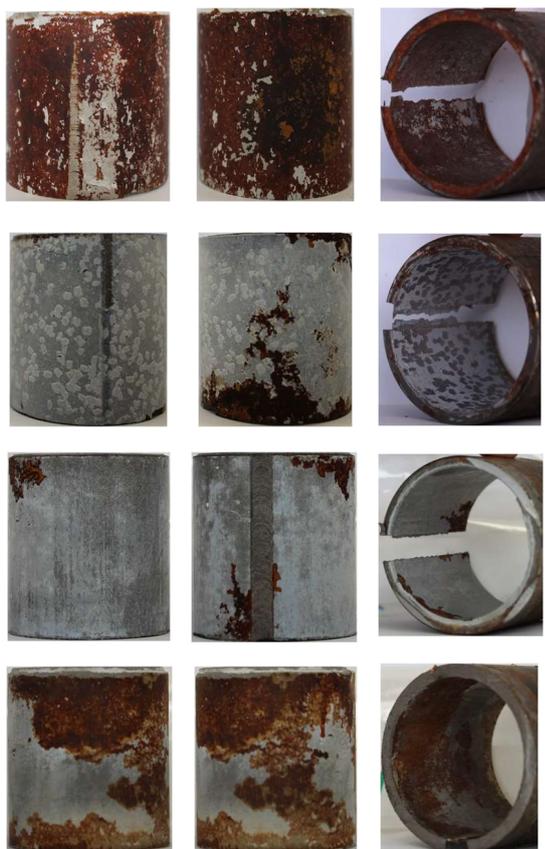
After testing, the metal casing encasing the sealants were milled off to enable the condition of the sealant/casing interface to be observed. The results of which are presented in **Figure 7**. As can be seen, the conditions at the sealant/interface for the different sealants are remarkably different. Sealant S1 exhibited a significant development of corrosion at the interface. From a parallel investigation, it was found that this casing/sealant interface corrosion created internal pressure that artificially increased the apparent bond strength and stiffness of Sealant S1.

Sealant S2 displayed an interesting formation of white patches occurring on both the outer surface of the sealant

and the inner surface of the metal casing. The formation of these patches would suggest that the bond failure in this particular sealant must be triggered by the combination of bond failure at the interface and the failure of the sealant material itself. A trace of minimal corrosion could also be observed.

Fig. 7. Sealant/steel interface conditions. From top to bottom: Sealants S1, S2, S3, and S4.

Sealant S3 exhibited the least corrosion amongst the four sealants tested. No formation of white patches was evident at the sealant/casing interface suggesting that the bond failure was attributed to the interface shear bond failure.

Sealant S4 displayed a notable formation of corrosion. This corrosion issue, alongside the large reduction in strength, was possibly due to the rapid setting of this particular sealant. Work is currently progressing to confirm this possible factor.

Sealant S2 exhibited a mixed mode of failure, involving bond failure at the sealant/steel interface and shear failure through the sealant material. A trace of corrosion was also evident despite relatively minimal.

Sealant S3 outperformed other sealants as it displayed relatively high apparent bond strength, with no indication of corrosion at the steel/casing interface. Failure was governed by the bond failure at the steel/casing interface. The improved performance of Sealant S3 might be related to the specific thermal properties of this particular sealant. Work is currently ongoing to confirm this possible aspect.
