Characterisation and monitoring of oil-well cements under simulated CCS well conditions

CEMENTTEGRITY Deliverables 5.1 – 5.6, v. 1
Published 2025-03-31

Authors: Benny Suryanto, Gerard Starrs
Heriot-Watt University, Edinburgh, United Kingdom

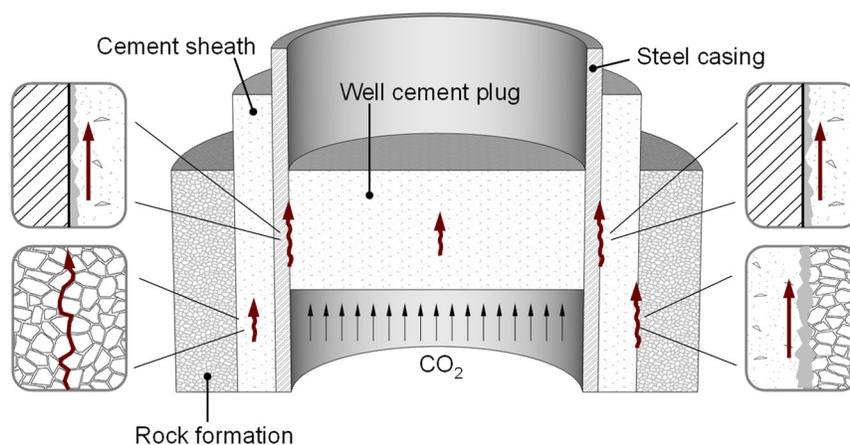
Figure 1. Schematic representation of possible leakage pathways in a CCS well.

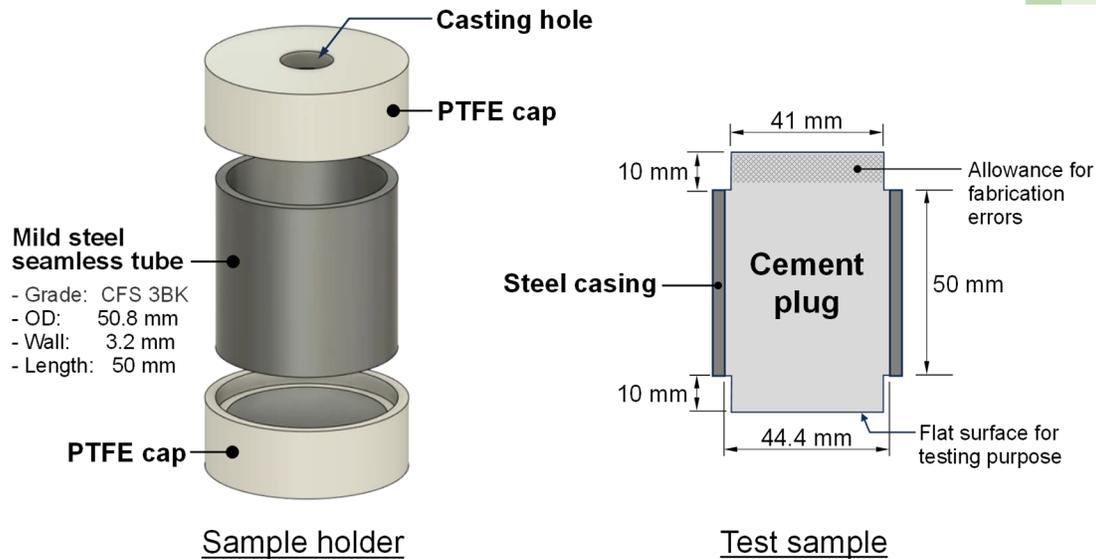
Figure 2. Schematic of test sample representing a miniature of a plugged wellbore.

The internal sealant cement plug had a diameter of ~44.4 mm and a 10 mm protruding end on either side, which had a diameter of 41 mm. These protruding ends were provided to minimise the boundary effects during mechanical bond testing: the top part was provided to remove the undesirable effects from the presence of relatively poor quality of material and uneven surface at the top during sample preparation, whereas the bottom part was to minimise stress concentration during testing. The manufacture of this protruding shape was facilitated by two PTFE end caps which encapsulated the sealant during sample fabrication and curing. The top PTFE cap had a 20 mm central hole for casting purposes, while the bottom cap was fitted without any alteration to provide a flat surface for bond testing.

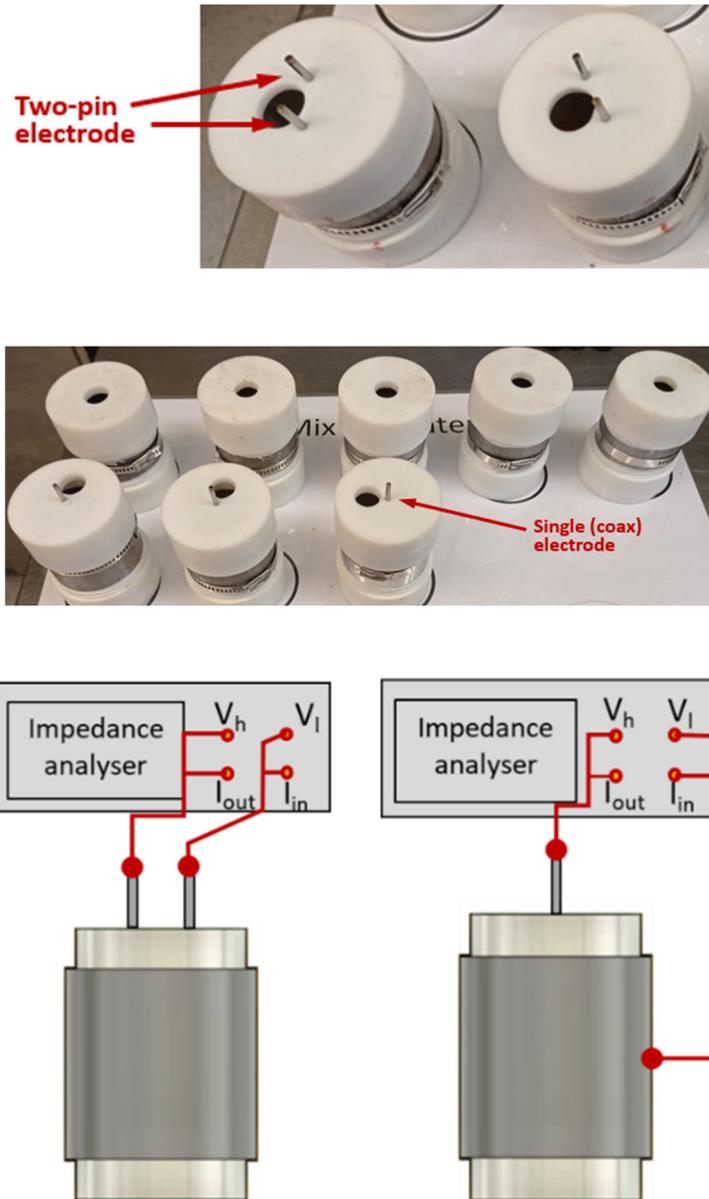
The final electrode design employed two miniature electrode configurations: the 2-pin parallel pair and the 1-pin coaxial, see **Figure 3**. The electrodes were significantly smaller relative to sample size to minimise restraint, thereby reducing the likelihood of cracking during high temperature curing. In the 2-pin parallel-

pair configuration, two marine grade steel rods, each 2.4 mm in diameter and spaced 15 mm (centre-to-centre), were positioned along the full length of the sample, to obtain its bulk electrical properties. Conversely, the 1-pin coaxial configuration utilised a single 2.4 mm diameter rod positioned along the centreline of the sample as the first electrode, with the steel casing serving as the second electrode. This coaxial configuration enabled impedance measurements through the sealant material and at the sealant/casing interface, thereby facilitating the assessment of the interface.

Figure 3. Schematic of 2-Pin (left) and Coaxial (right) electrode configurations.

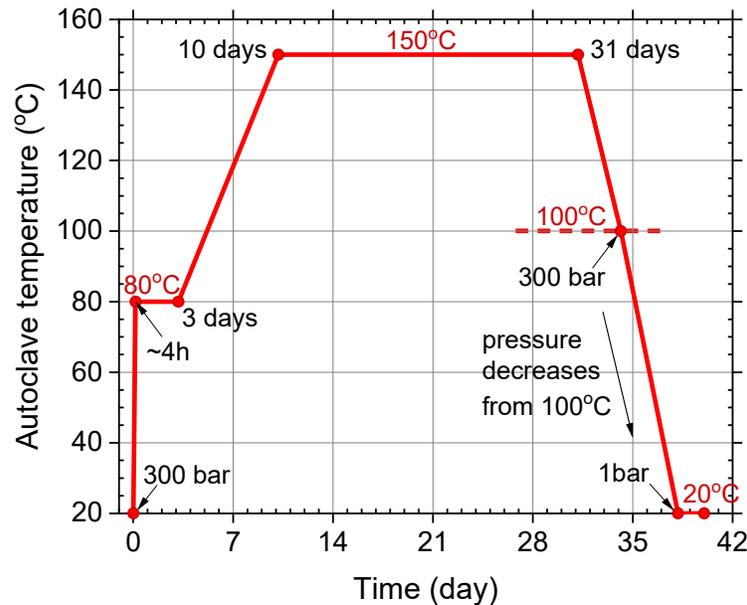
During the high temperature curing, Resistance data was gathered every 30 minutes to track the sealant hydration and hardening process. At the end of the curing regime, all samples were placed in water under wet hessian cloth in sealed plastic containers and air transported from Norway to HWU in the UK. The sample containers were then stored at laboratory temperature ($20\pm 1^{\circ}\text{C}$) until required for testing.

Figure 4. Schematic representation of the curing regime.

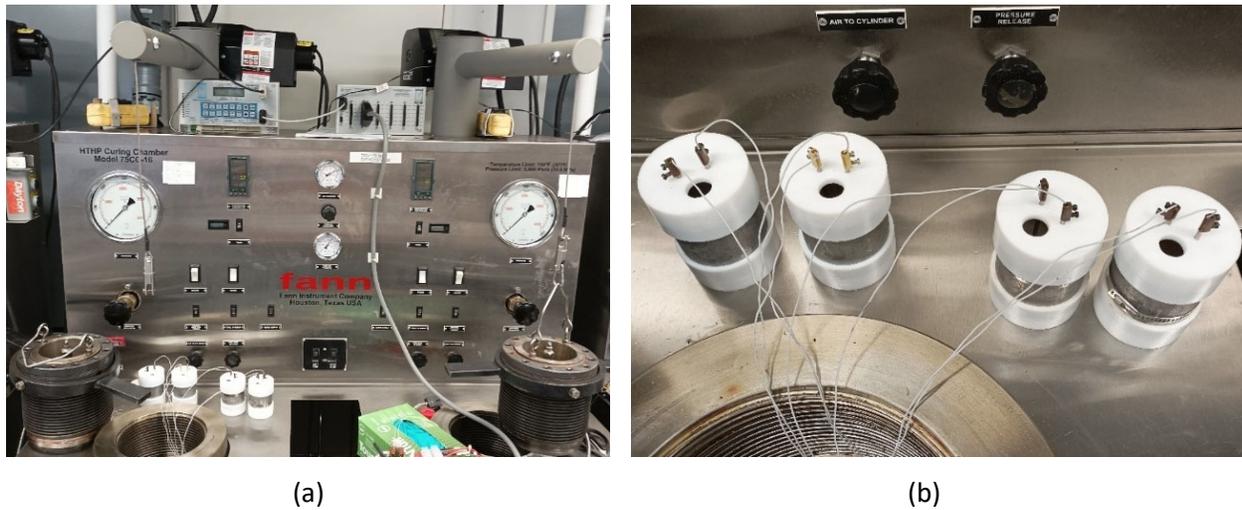
Once the slurry was sealed in the casings, the samples were placed in the autoclave chambers in an aqueous containment fluid. For each sealant type, two samples of the 2-pin electrode type were connected to a logging system capable of tracking *in-situ* low frequency (i.e. direct electrical current) Resistance during the curing period. As noted above, these samples were housed in a separate chamber with an electrically inert mineral oil containment fluid to prevent contamination of the electrical measurements. A bespoke logging system was used, comprising a programmable logger that generates a square wave measurement voltage of 1 V peak-to-peak and stores the current response of each sample as a resultant Resistance value. The logger was interfaced to the samples via a multiplexer unit that allows up to 72 separate measurements per cycle. The logger and multiplexer units, along with the autoclave system and 2-pin electrode samples ready for containment in the autoclave system, are shown in **Figure 5**. Each sample was connected to thin lead wires that were interfaced to the multiplexer via a special 8-wire feedthrough connector.

Figure 5. (a) Logging system placed above the two-chamber autoclave and (b) 2-pin electrode samples ready for testing.

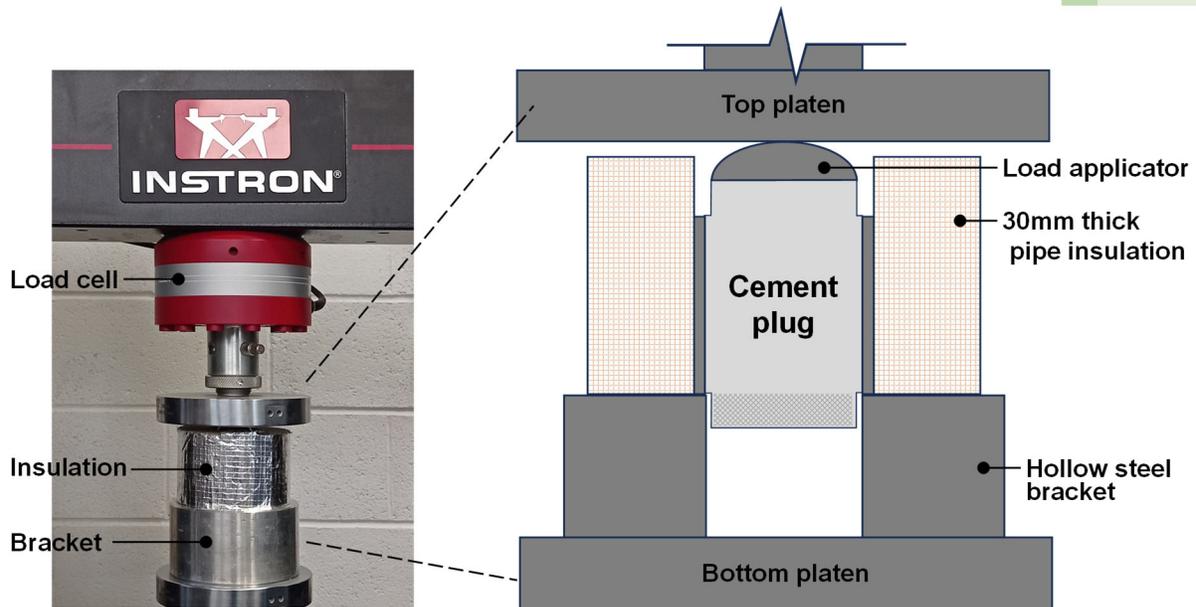
Prior to the commencement of each test, each sample was removed from the chamber and then tightly wrapped with a 30 mm-thick pipe insulation to minimise temperature loss. The sample was then placed on a central-hollow steel bracket (pre-conditioned at 80°C) in an upside-down position to present the flat face of the sample to the loading plate on top. The load was then applied through a hemispherical steel plate placed on the top of the sealant in a force-controlled manner, at a rate of 5 kN/min. The machine automatically stopped when a sudden drop of resistance (i.e., > 20%) occurred, due to either sliding or crushing of the inner cement plug. Each test took approximately 5 to 10 minutes to complete and hence can be considered as being quasi static in nature.

Figure 6. Schematic diagram of bond test.

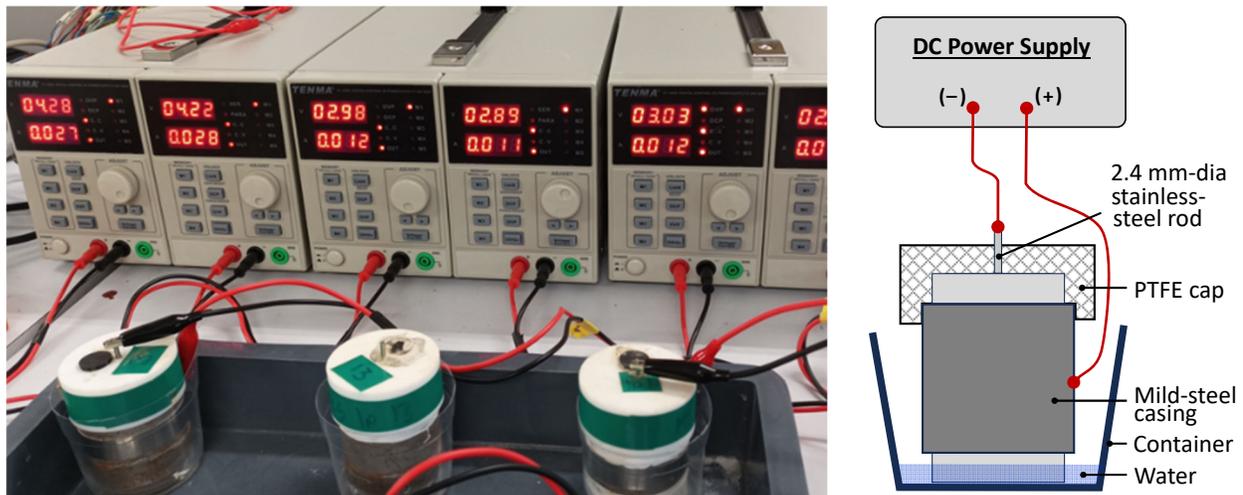
A schematic diagram of the accelerated corrosion tests and the corresponding samples is presented in **Figure 7**. Each sample contained 2.4mm diameter stainless-steel rod embedded along the longitudinal axis of the sample at the time of casting. These samples were stored under water for 25 days. As illustrated in the schematic diagram, the lower part of the samples was immersed in water in a small plastic container. On the same day (Day 26), four of the samples were connected to a DC power supply to artificially induce corrosion. This was done by connecting the stainless-steel central rod to the positive terminal of the power supply (acting as a cathode) and the metal casing to the negative terminal (acting as an anode). Two of the samples were exposed to a constant current of 15mA and the other two to 30mA, corresponding to an average current density of 0.21 and 0.42 mA/cm², respectively. They were connected to the power supply for 6 days, followed by 1 day rest to allow for various measurements to be undertaken (discussed in another article). This continued on a weekly basis until required for bond testing at 90 days. The remaining three samples were left unconnected and used as a benchmark. During the testing period, half-cell potential measurements were taken (between the stainless-steel rod and the mild-steel casing) to evaluate the likelihood and presence of corrosion.

Figure 7. Photo and schematic diagram of accelerated corrosion exposure test.

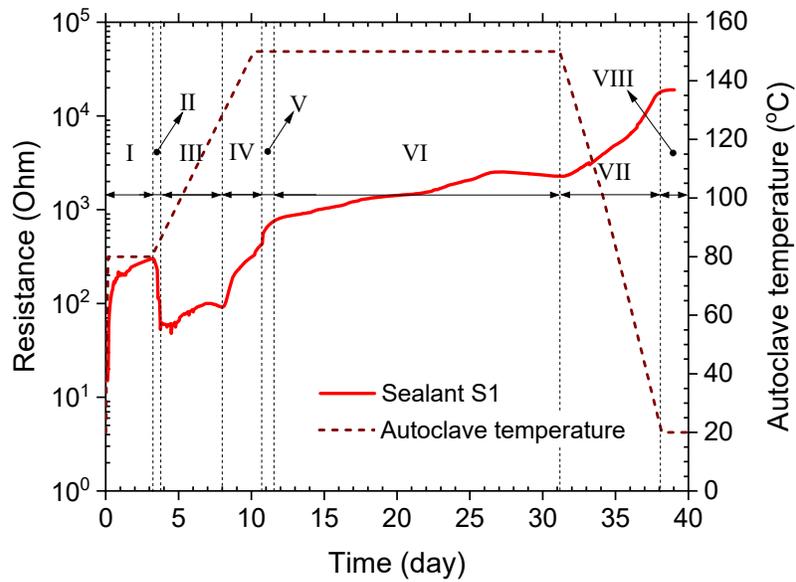
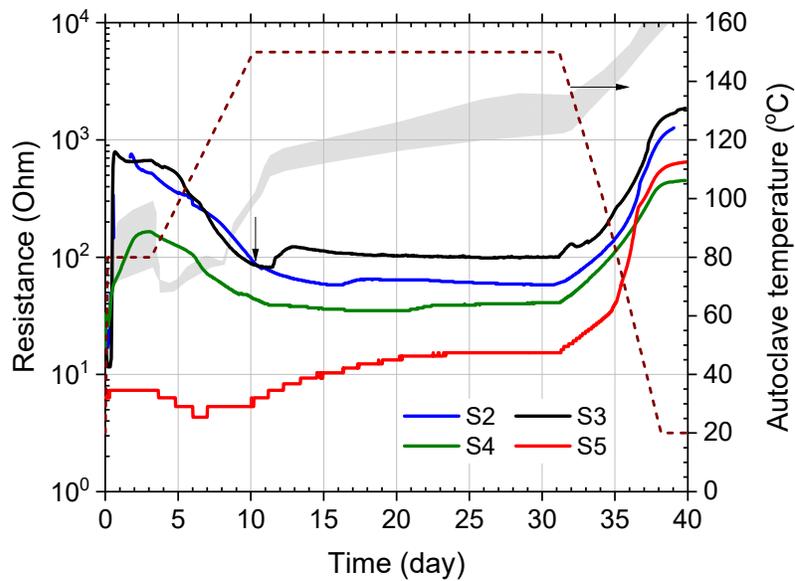
Figures 8(a) and (b) illustrate the Resistance profiles of all sealants during the enhanced curing process presented along with the temperature profile. Referring to the response of Sealant S1 in **Figure 8(a)**, during the initial 3 days at 80°C, a gradual increase in Resistance was observed reflecting early development of a pore structure due to Portland cement hydration (Stage I). The trend was then reversed briefly once temperature started to increase (Stage II), with Resistance dropping with increasing temperature. This resulted from the temperature effects noted above. However, in less than one day, as temperature continued to increase, the accelerating hydration and pore development overcame this trend, causing the Resistance to increase again (Stage III). The rate of the Resistance increased becomes more pronounced at around 130°C (Stage IV) and 150°C (Stage V), likely indicative of the active engagement of silica flour in the hydration process. Once the temperature was stable at 150°C, the Resistance continued to increase at a lower rate, revealing continued development of the microstructure as hydration proceeded. The Resistance appeared to level off towards the end of Stage VI, indicating that the material has reached full hydration. Shortly after 31 days, the temperature was steadily reduced from 150°C to 20°C, causing the Resistance of the cured material to increase towards a much higher value following its negative temperature response before plateauing (Stage VIII).

The Resistance profiles of sealants S2, S3, S4 and S5 are shown in **Figure 8(b)**, along with the Autoclave temperature profile and variation in the Resistance of Sealant S1 (shown in shaded grey area). As with Sealant S1, the Resistance was observed to be correlated to temperature throughout curing, but with each sealant showed measurably different absolute values of resistance as well as individual distinguishing characteristics as hydration reactions proceeded. Such pattern modifications at key stages were due to the specific individual materials and additions present in the sealants. For example, Sealants S2 and S3 samples displayed similar curing profiles in the early stages, which is characterised by a rapid increase in Resistance at approximately 6 hours after the temperature had reached 80°C. While the temperature was

Figure 8. Resistance profile: (a) Sealant S1 and (b) Sealants S2–S5 during enhanced curing.

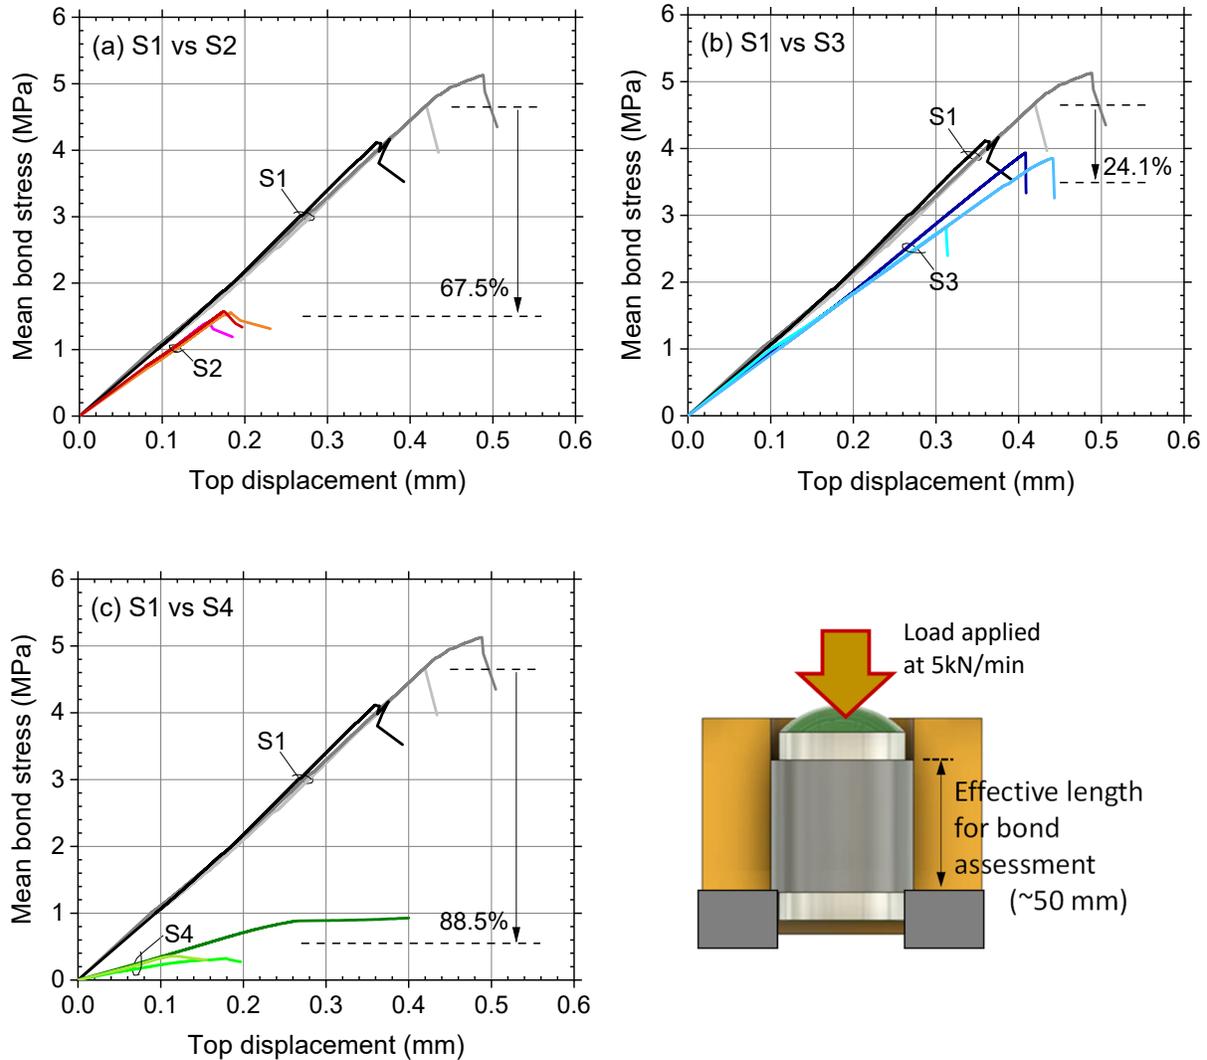
Figures 9(a)–(c) display the mean bond stress vs top displacement relationships for the initial four sealants, with each Figure comparing the results of three notionally identical samples for each sealant with those of Sealant S1. The results for Sealant S5 samples are explained in the following section, as this batch was tested during the second half of the project with a different reference. In general terms, the comparisons presented indicate that all sealant samples displayed a similar increase in the mean bond stress with increasing displacement until failure, which occurred suddenly due to sliding of the sealant in the vertical direction.

The results presented in **Figures 9(a)–(c)** show that the individual sealants exhibited varying bond strengths and overall stiffnesses, with both parameters decreasing in the order: S1 < S3 < S2 < S4. For instance, in case of Sealant S2 samples, the mean bond strength and stiffness were 1.51 MPa and 8.95 N/mm³, which are only 32.5% and 80.6% of those of Sealant S1 samples, respectively. Sealant S3 samples exhibited higher mean bond strength and stiffness, with mean values of 3.54 MPa and 9.20 N/mm³, corresponding to 75.9% and 82.9% of those of the reference value, respectively. Sealant S4 samples demonstrated the lowest mean bond strength (= 0.54 MPa), which is only 11.5% of that of the reference sealant, and the lowest overall stiffness (= 2.88 N/mm³, or only approximately 26% of that of Sealant S1). This might be attributed to sliding shear movement between the sealant and the steel casing during testing.

Figure 9. Mean bond stress–top displacement for Sealants S1–S4.

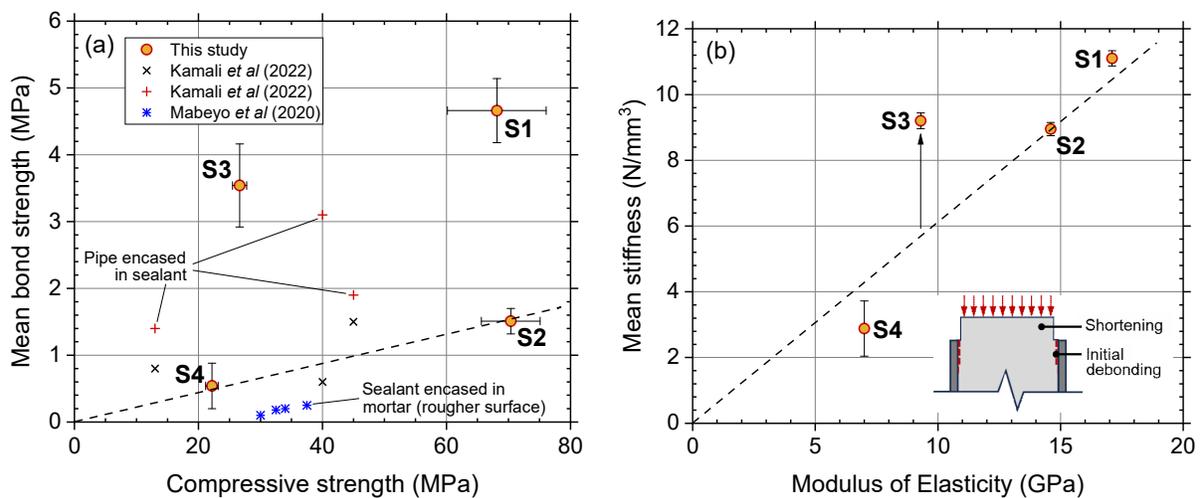
Direct comparisons of the mean bond strengths obtained from previous studies are difficult due to the scarcity of published values, with most samples being cured at ambient or limited curing pressure. However, some comparisons are provided in **Figure 10(a)**. It is of interest to note that the mean bond strengths of Sealants S2 and S4 samples lie within the range of reported values, whereas those of Sealants S1 and S3 samples are generally higher. Interestingly, the mean bond strength of Sealant S2 samples (= 1.51 MPa), which contains expansive agent, is comparable to the 1.5 MPa average reported recently by Kamali *et al* (2022), which was obtained from cement test samples containing magnesium oxide expansive agent. By contrast, the mean bond strength of Sealant S1 samples (= 4.66 MPa) is much higher than the 0.6 MPa average obtained from the same study, measured on Portland cement (type G) cement samples encased in metal casing; these samples were cured in 90°C chamber at 34 bars for only 7 days. **Figure 10**

also shows that the mean bond strength of Sealant S1 samples is also higher than the 1.4–3.1 MPa range obtained from metal pipe encased in sealant, and the range 0.12–0.26 MPa reported by Mabeyo *et al.* (2020) for cement samples encased in cement mortar and cured in 80°C water bath at ambient pressure over a 28-day period. Therefore, it is possible that the lower bond strength of Sealants S2 and S4 observed earlier in **Figures 9(a) and (c)** is not due to their reduced strengths, but rather because of the elevated bond strengths of Sealant S1 and S3. In addition to bond strength, the apparent stiffness determined from the shear bond test can also be analysed. The overall stiffness of the curves can be mainly attributed to the deformation of the top protruding part of each sample under loading and the initial slip between the sealant and the metal casing during bond testing, in addition to the deformation of the entire test setup, which can be expected to be similar for all samples. Therefore, comparing the overall stiffness obtained from each sealant with their modulus of elasticity (MOE) could provide an indication of the extent of initial slip experienced during the test.

Figure 10. Comparisons of bond test results with basic mechanical properties.

Figure 10(b) compares the overall stiffness obtained from each sample plotted against their respective MOE value. Note that the MOE of each sealant was measured in WP 1 on notionally identical materials cured at 150°C and 300 bar for 28 days, producing compressive strengths of 107, 76, 32, 21 MPa for Sealants S1 to S4, respectively. It is evident from the Figure that the overall stiffness obtained from bond testing exhibits an almost linear relationship with MOE. The only exception is Sealant S3, which displayed higher stiffness than the linear relationship (indicated by an arrow). This indicates that this sealant might have experienced less sliding during bond testing than the other sealants. Sealant S4 exhibited slightly

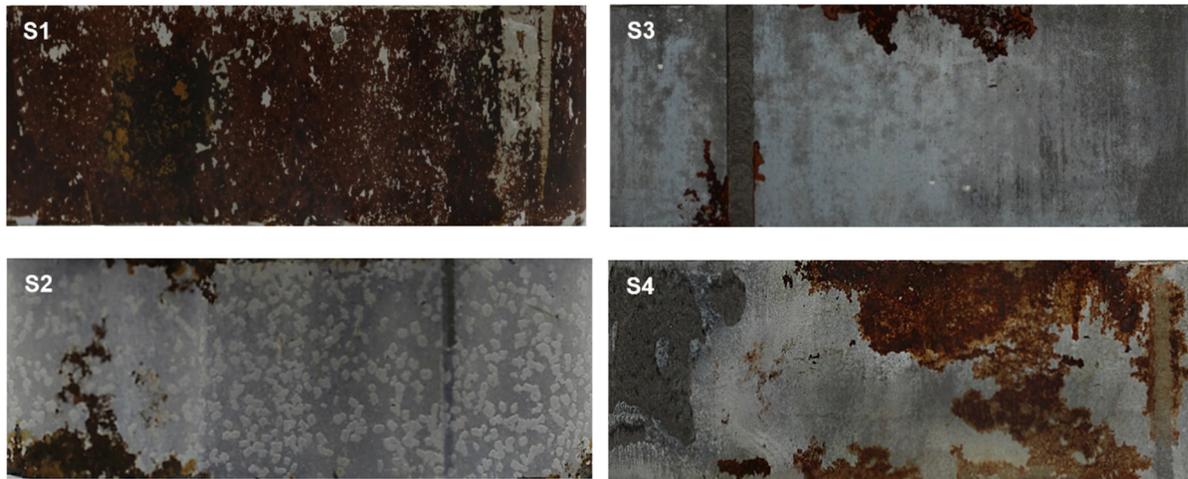
Figure 11 displays the acquired images from each sealant sample. Sealant S1 samples displayed a significant presence of corrosion products on the entire surface of the sealant, primarily in dark brown and black colours. Few patches of the original surface of the sealant were apparent as the rust layer came off during the extraction, or due to the milling process as shown in the right-hand side. Sealant S2 samples displayed an interesting surface pattern, comprising small white/light-grey patches dispersed across a darker grey background. On examination, the white/light-grey zones were found to be the material that had been directly adhered to the steel surface but had separated under the application of shear load. The darker background is the exposed sub-surface of the sealant material immediately beneath the sealant/steel interface, an effect resulting from the separation of the still adhering sealant surface from the sample body. Thus, it is inferred that apparent bond failure of the S2 samples results from a combination of material failure beneath the steel/material interface, and *partial* failure of the sealant/steel bond. Sealant S3 samples, like Sealant S2, displayed only a minor extent of corrosion, concentrated primarily at both ends of the sample. In contrast, however, Sealant S3 samples exhibited a clean surface representing the appearance and texture of hardened cement paste in general. As shown in **Figure 12**, the inner surface face of the tube was also relatively clean, with a minor extent of corrosion present. This would indicate that failure of Sealant S3 samples was governed by bond failure at the interface between the sealant and metal casing. Sealant S4 samples displayed a moderate level of

corrosion (brighter in colour) and the presence of a failure surface where a layer of the sealant material near the interface spalled off. Other than these regions, the remaining surface appeared to be clean.

Figure 11. Montage of the sealant surface post testing.

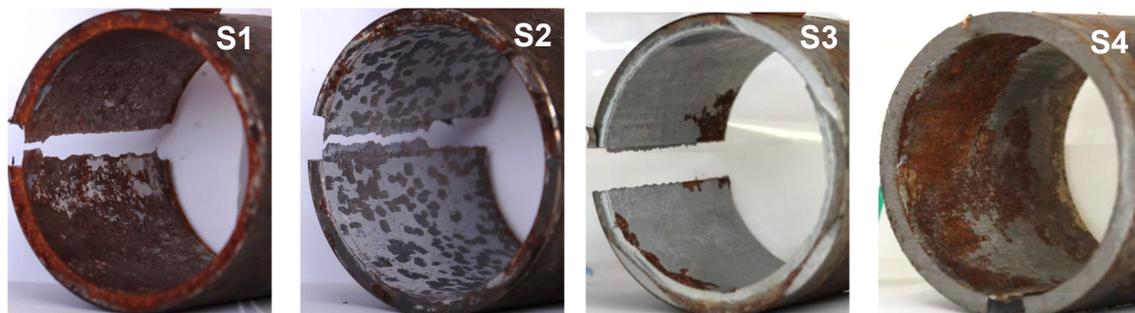
Figure 12. Surface condition of the inner pipe post bond testing.

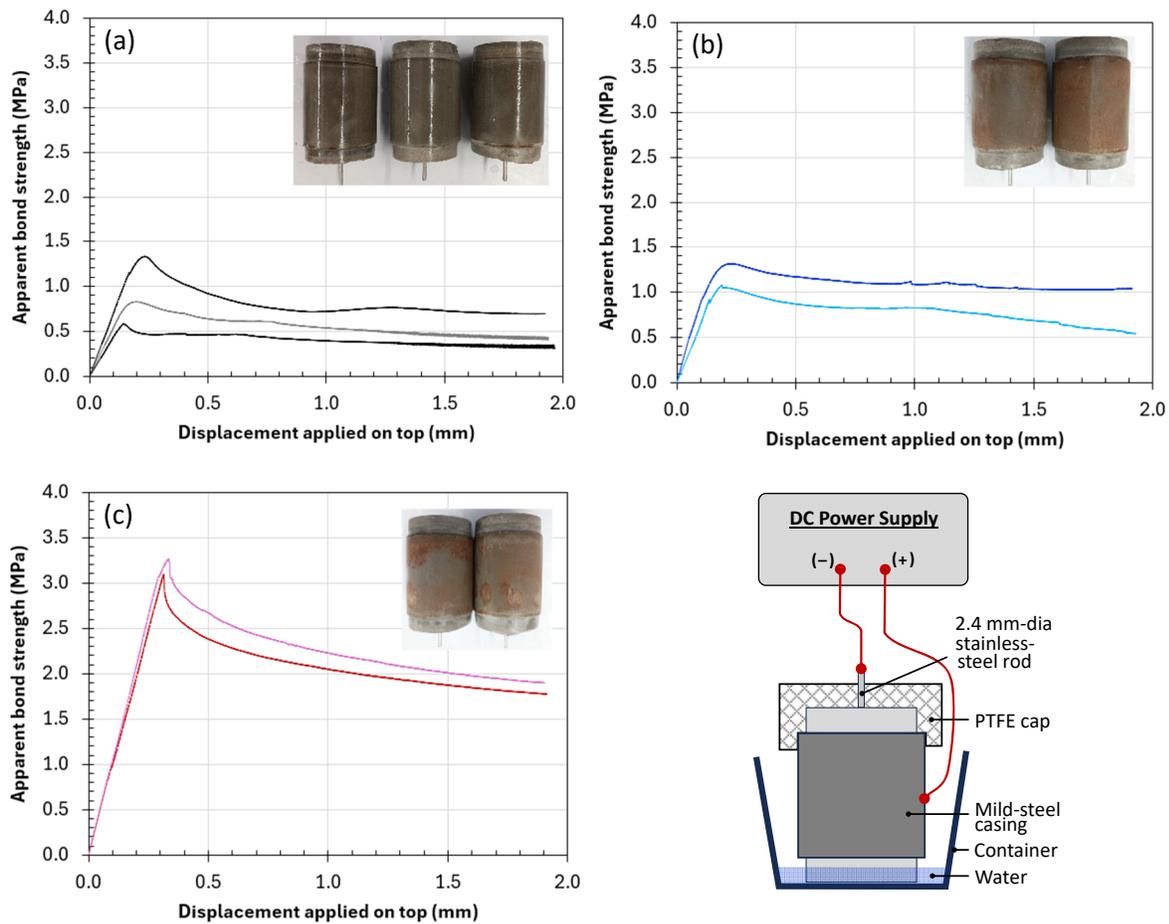
Figure 13 displays the 90-day mean bond stress vs top displacement relationships for the three groups of S1 sealants, with the tests performed at 20°C and under a crosshead speed of 0.2 mm/min. It is evident that there is a noticeable difference in bond performance between the three groups of samples in terms of bond strength and overall stiffness. In general, an increase in the 90-day mean bond strength with increasing current levels is evident, from 0.91 MPa at 0 mA to 1.19 MPa at 15 mA (or 30.8% increase) and 3.18 MPa at 30 mA (349% increase). This confirms the above postulate that the enhancement in bond strength is affected by the extent of corrosion at the sealant/casing interface.

Figure 13. Results of bond test on samples exposed to accelerated corrosion.

Regarding the Plots shown in **Figure 23(b)**, it is evident that for samples exposed to zero current (left-hand-side plot), the impedance spectra showed a consistent shift to the right, suggesting continued hydration. No significant alterations to the spur at the low-frequency end of the curve were observed. In samples subjected to a 15mA current (middle plot), a similar trend is evident, although there are noticeable changes in the radius of the spur at the low-frequency side of the curve, which may indicate corrosion occurring at the sample/sealant interface. For samples exposed to a current of 30mA, a more significant to the right is observed, suggesting that prolonged exposure to the current influences not only the sample/casing interface but also accelerates the cement hydration process. This could account for the previously observed increase in apparent bond strength, see **Figure 13**.

a final region where resistance continued to increase, driven primarily by further curing effects and likely corrosion at the interface. The observed increase in bulk resistance would suggest that the application of electrical current must have enhanced cement hydration, which may have contributed in part to the previously observed increase in apparent bond strength (see Figure 13).

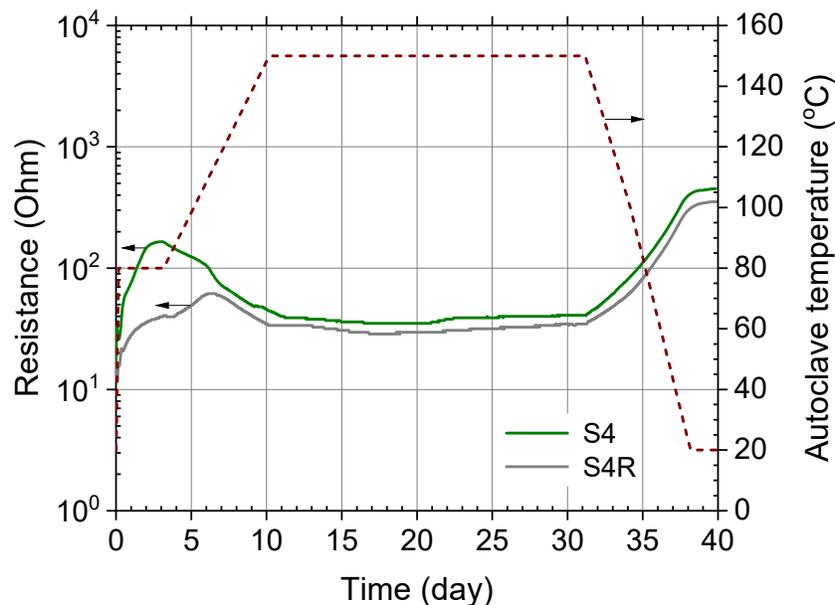
In view of above, it was considered necessary to study the effect of setting time. The testing for Sealant S4 was repeated to check if the low bond strength observed was attributed to its rapid setting characteristic. Hence, in the repeat test, a retarding agent of undisclosed type and quantity was added to the original mix to slow down the initial reaction kinetics of the cement. The same test procedures, with elevated curing temperature and pressure, were implemented as previously. **Figure 14** compares the original S4 result with S4R. Beyond the 6-day point (above 110 °C) the profiles of both samples are largely similar, though S4R has slightly lower Resistance but is still within the range of variation expected between the two batches. This suggests that the inclusion of the expansive agent does not have a significant influence on the bulk properties of the sealant, particularly in terms of pore connectivity. However, the addition of the retarding agent has clearly influenced the initial profile of the electrical response, with the S4R sample displaying significantly delayed and reduced Resistance from gauging through the first 7 days, when compared to the original S4 sealant. This demonstrates the distinct effects of the retarding agent on the setting process and the resulting development of pore structure during the early stages of curing. The influence on the later stages of curing appears minimal, as reflected in the observed similarities, including the slight increase in value around the 20-day mark and the consistent final increase. This further confirms that the inclusion of the retarding agent primarily influences the early stages of hydration.

Figure 14. Resistance profile of Sealants S4 (original) and S4R (repeat with retarding agent).

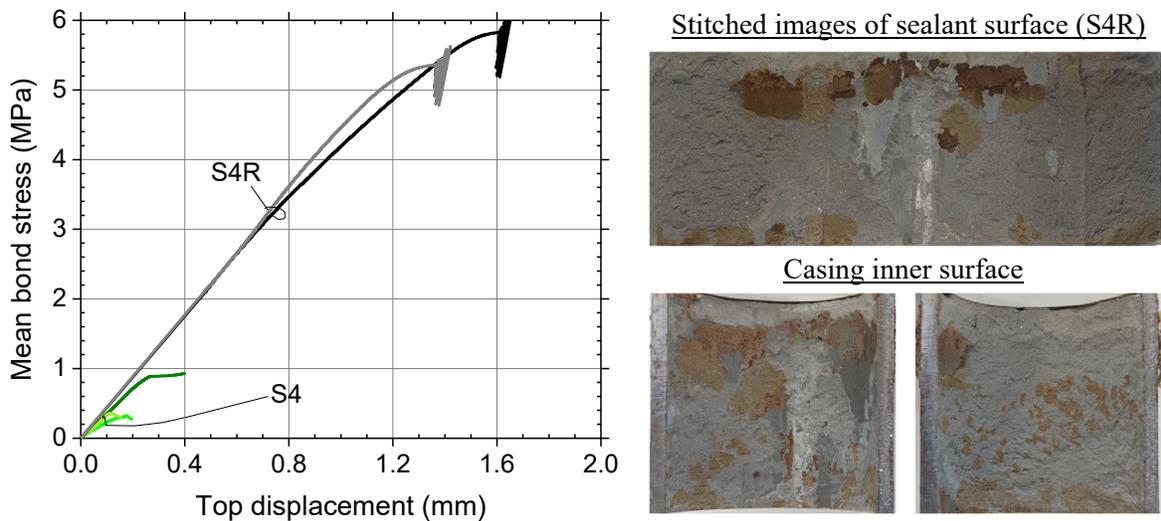
Prior to bond testing, radial cracking was observed at the bottom part of the material protrusion above the casing rim, through which the bond test load is applied. This required milling of the sealant material flush with the steel casing rim, to enable load application during the bond test. The mechanism underlying the radial cracking due to the addition of expansive agent is not fully understood but might have resulted from tensile stress developed in the protrusion above the steel rim due to the restraint on volumetric changes of the sample body during curing imposed by the steel casing. **Figure 15** compares the mean bond strength obtained from this repeat test (denoted S4R) with the original test (denoted S4). It is immediately apparent that the mean bond strength of the repeat samples was significantly higher than that of the original S4 mix, averaging at 5.45 MPa, clearly highlighting the benefits of slowing down the initial reactions of cement on bonding. This corresponds to an approximately five-fold net increase once the difference in the mean bond strengths of the reference samples in the two batches has been considered. Interestingly, it was found that failure of the repeat samples was governed by crushing of the sealant face under the loading applicator instead of shear sliding at the sealant/steel interface. Following bond testing, the metal casing was split into two to get access to the sealant and inner casing surface, see **Figure 15**. Interestingly, there is a large proportion of the sealant material still strongly adhered on the steel surface, confirming the high bond strength observed. Despite this, a moderate level of corrosion, comparable to that observed in the S4 mix was evident, suggesting that corrosion is governed by the sealant characteristic itself.

Figure 15. Bond performance of Sealant S4R with a retarding agent compared to that of reference Sealant S4 without a retarding agent, along with images of surface conditions post testing.

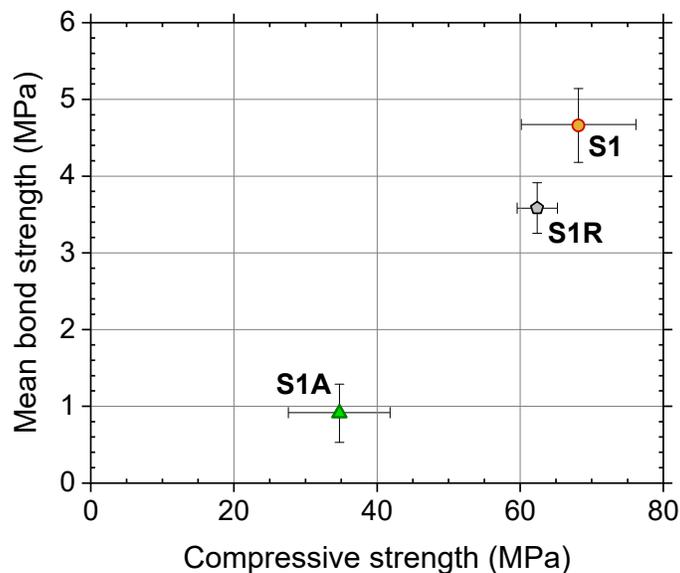
Cement hydration involves complex chemical processes that are thermally activated. The in-situ elevated temperature and pressure environment of a deep re-purposed oil or gas well should therefore be replicated in the curing and testing of CCS sealant materials as closely as possible. **Figure 16** compares the mean bond strengths obtained from test samples cured under elevated temperature and pressure (up to 150°C and 300 bar over 38 days, denoted S1 and S1R) and those cured under laboratory condition (20°C and atmospheric pressure over 28 days, denoted S1A), plotted against their respective mean compressive strengths. Note that S1R was obtained from sealant samples encased in stainless-steel, whereas S1 and S1A are from a similar sealant encased in mild steel. The beneficial effect of enhanced curing is strongly indicated by the bond and compressive strengths of samples cured under elevated conditions (S1 and S1R), compared to those cured under ambient temperature and atmospheric pressure (S1A). It is interesting to note that while enhanced curing resulted in an approximately twofold increase in compressive strength (~35 MPa to 60–75 MPa range), it resulted in four to fivefold increase in bond strength (~0.9 MPa to 3.6–4.6 MPa range). The elevated pressure used in the main curing regime (300 bars) is anticipated to enhance the densification of the pore structure of the sealant, thereby increasing its compressive strength. Additionally, the elevated pressure can minimise volumetric changes (e.g. shrinkage). These two factors contribute positively to bond strength, explaining the more pronounced improvement observed in the overall bond strength, see **Figure 16**.

Figure 16. Key properties of Sealant S1 cured under ambient and elevated curing.

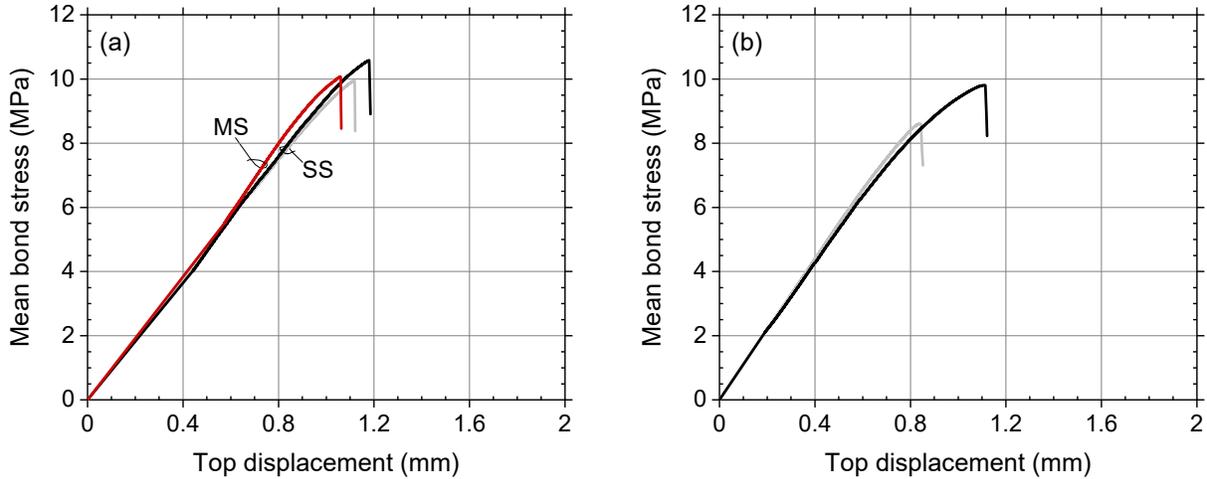
Figure 17 displays the mean bond stress plotted against displacement, using the same data presentation as before. Sealant S5 samples achieved a mean bond strength of 10.2 MPa regardless of the casing materials used (e.g., mild steel or stainless steel), whereas the bond strengths of the repeat S1RF samples ranged from 8.76 to 10 MPa, averaging 9.4 MPa. These values were more than twice the average bond strengths recorded in previous batches and exceeded figures reported in published literature. The reasons for this increase were not clear, but several factors may have contributed. Potential causes include inconsistencies during the oil removal process in the preparatory stage or errors in material batching. In the case of the latter, this may include, for instance, the accidental addition of a retarding agent (which has previously been shown to enhance bond strength) or the unintended use of an expansive agent during material batching. Furthermore, issues arising during transportation from Norway to the UK could also be a factor, although such complications would typically be expected to reduce bond strength rather than enhance the value.

Figure 17. Bond performance of: (a) Sealant S5 and (b) Sealant S1RF (repeat).

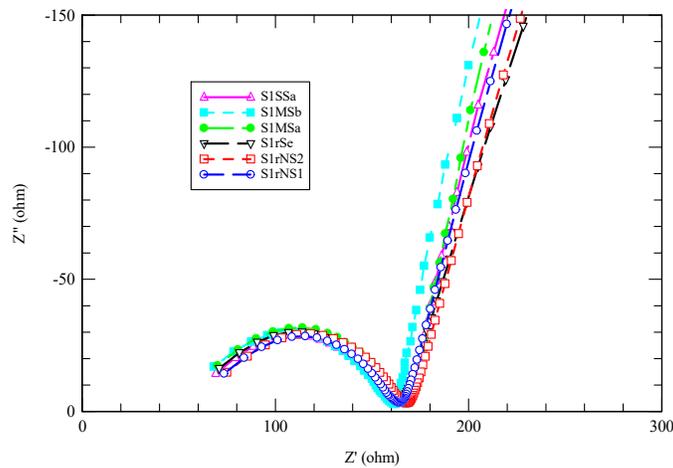
Figure 18. Comparison of the Impedance response of Sealants S1 (first 3 data sets) and S1RF (second 3 data sets).

To examine the aforementioned issue further, impedance measurements were conducted on the test specimens prior to undertaking the bond testing. The findings, illustrated in **Figure 18**, demonstrate a consistent response, suggesting that the bulk electrical properties remain fundamentally unchanged across the samples between the two batches. Therefore, any discrepancies observed are likely to be due to factors relating to the sealant-casing interface. This could be due to the unintentional presence of an

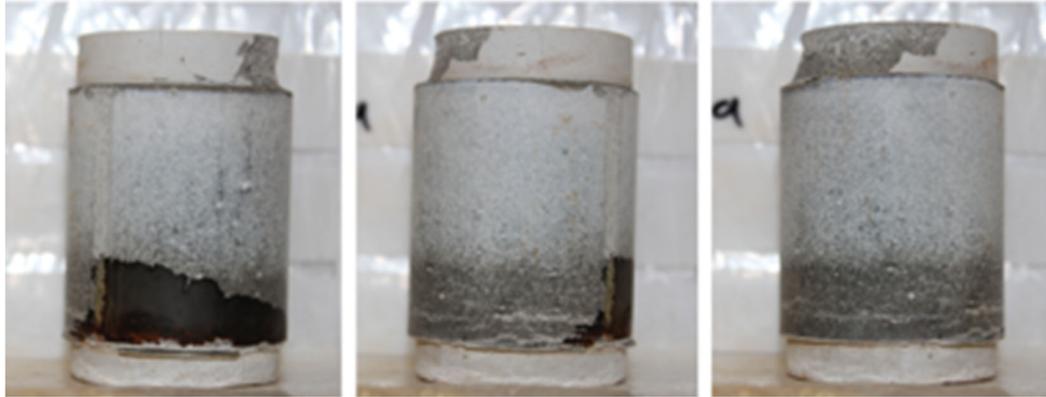
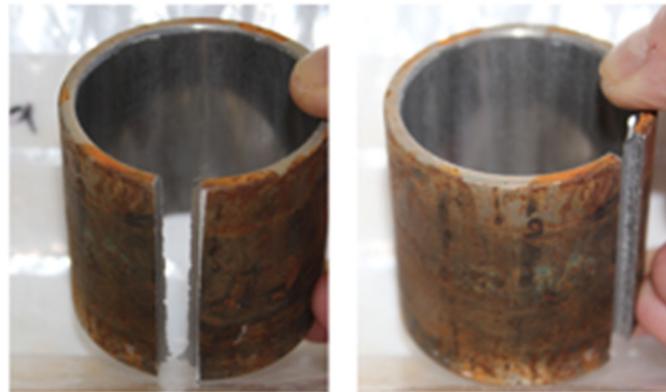
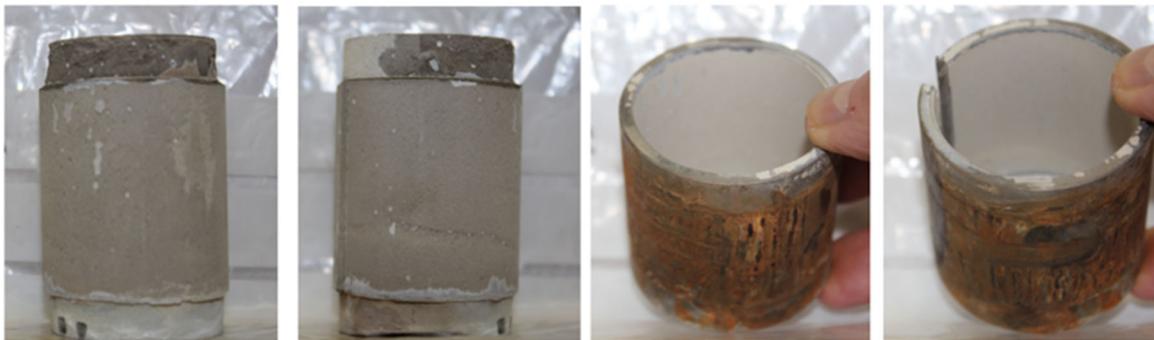
Figure 19 (a) displays the surface conditions of the Sealant S5 samples, showing both the outer surface of the sealant and the inner surface of the steel casing. Notably, the particular sealant exhibits a remarkably smooth interface with the steel casing, exhibiting minimal and largely no visible signs of corrosion with the exception of only at a small, localised area as shown in the Figure. Among the various sealants tested in this project, this sealant displays the smoothest surface, effectively replicating the texture of the internal surface of the steel casing. A noticeable layering effect can also be seen, which is indicative of material segregation during the fabrication of the samples. This is likely attributable to its less viscous property compared to the other sealants tested in this study. The upper sections of the samples display lighter colour covered with numerous white spots, while the lower sections display a darker colour, also covered with several white spots.

For comparative purposes, **Figure 19 (b)** displays the surface conditions of the Sealant S1RF samples, both on the exterior surface of the sealant and the inner surface of the steel casing. Interestingly, there are also no visible signs of corrosion, which contradicts the results from the previous three batches. It is noteworthy that in this batch, the material near the surface has sheared off, leaving white zones adhered to the steel surface, suggesting that this layer must have separated under the application of shear load. This observation implies that the bond failure of the S1RF samples is due to material failure beneath the steel/material interface instead of debonding. While the exact cause of the difference could not be determined due to the use of a proprietary mix, the lack of corrosion in this set of samples could be attributed to enhanced volumetric stability compared to the original S1 sealant produced in previous batches.

Figure 19. Conditions of the sealant's outer surface of and the pipe's inner surface following bond testing: (a) Sealants S5 and (b) S1RF.

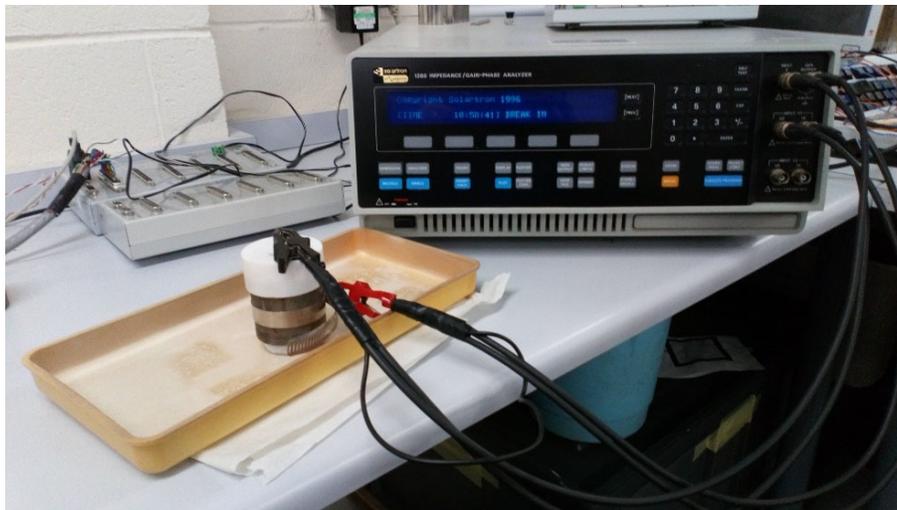
From parallel measurements, the value of k , the sample-electrode geometric parameter, was established for both the coaxial and parallel 2-pin sample configurations by comparing the impedance results from each with those from the Perspex cube sample holder. The values obtained for the coaxial and two-parallel pair electrode configurations were, $k_{1p} = 0.1568$ and $k_{2p} = 0.1046$ /m.

Figure 20. Solartron 1260 Impedance analyser with coaxial sealant sample.

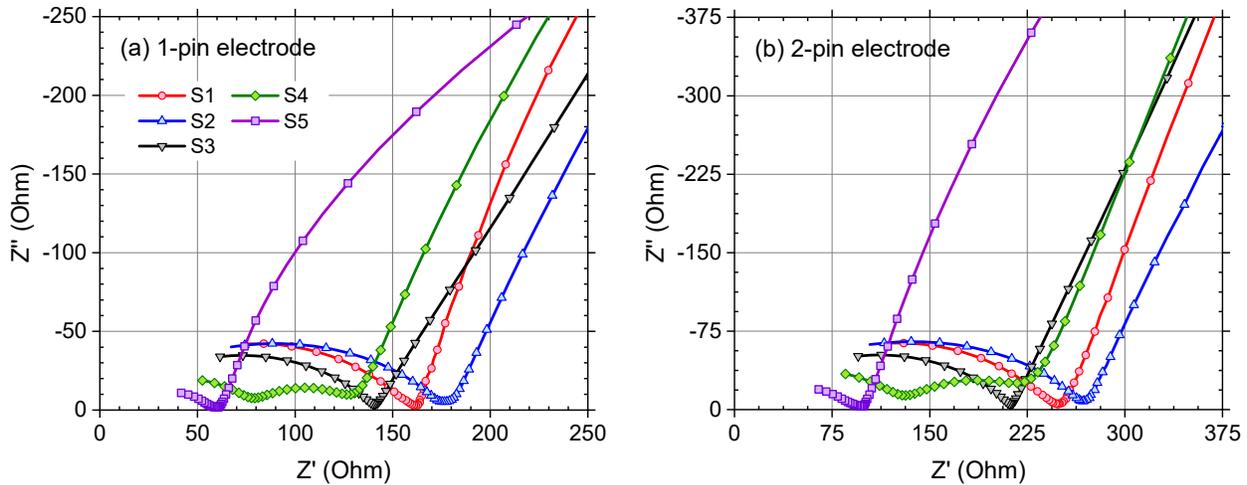
The processed Impedance results for Sealants S1 to S5 are presented below in **Figure 21** in Nyquist diagram format, with Reactance plotted as a function of Resistance as frequency increases from 1Hz to 10MHz. The plots for S1, S2 and S3 show a visually similar pattern proceeding from right to left as frequency is increased. This is essentially a long spur/tail, and a shallow arc conjoined at a *cusp point* where the Reactance reaches a minimum value. Superficially, this is the same pattern shown by plain OPC. The right-hand tail (low frequency section) of the response is determined not simply by the sample material properties but largely by the interaction of the material and electrodes at their interface. In the case of the coaxial configuration this includes the sealant/casing interface. It is observable that the absolute impedance values as well as the frequency characteristics of this part of the response are

distinguishable for each sealant. They are also distinguishable between electrode type – particularly for Sealant S5.

Figure 21. Post-curing Impedance plots of Sealants S1–S5.

Of interest is the Impedance response of Sealant S4, in that it reveals a dual-arc feature instead of a single-arc feature, as displayed by the other four sealants. It is notable that this sealant is derived from a different cementitious material (calcium aluminate) and contains several undisclosed proprietary additions. Similar Impedance features have previously been observed in OPC based materials containing supplementary additions.
