Characterisation and monitoring of oil-well cements under simulated CCS well conditions

CEMENTTEGRITY Deliverables 5.1 – 5.6, v. 1
Published 2025-03-31

Authors: Benny Suryanto, Gerard Starrs
Heriot-Watt University, Edinburgh, United Kingdom

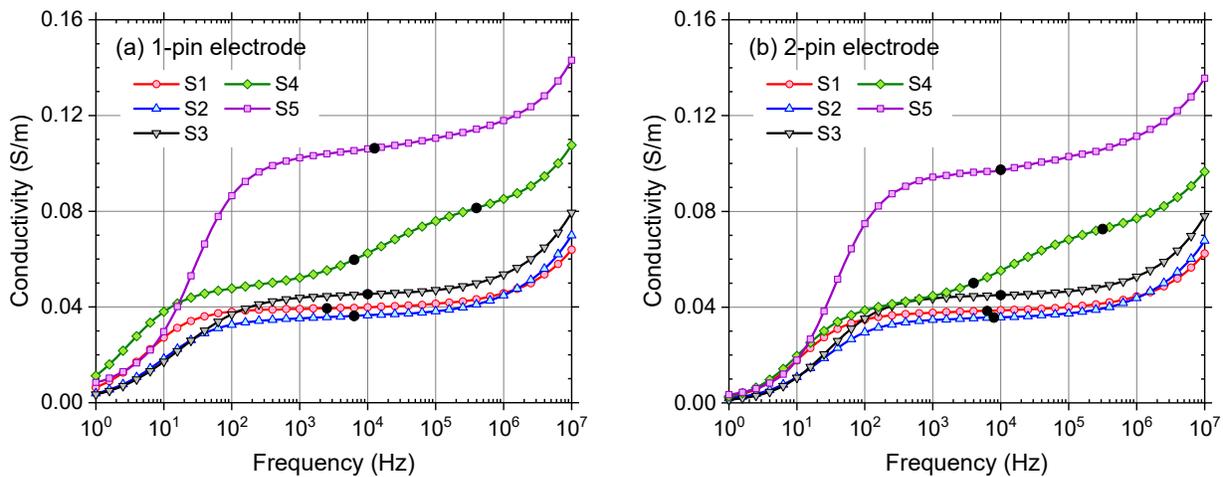
the order of $S2 < S1 < S3 < S4 < S5$, with values ranging from 0.036 S/m to 0.010 S/m, see **Tables 3 and 4**. Conductivity is, however, influenced by the pore-fluid conductivity, which can affect the bulk conductivity value, although this is not expected to differ significantly among the three OPC-based sealants. Considering the bulk conductivity values of these three sealants, Sealant S2 is anticipated to be less permeable than Sealant S1, whereas Sealant S3 is likely to be more permeable than Sealant S1. Due to the presence of chemical activators (alkali), Sealant S5 is expected to have a significantly higher ionic content which is likely to have elevated its pore-solution conductivity (e.g., studies have suggested 2-3 times higher), thereby resulting in a higher overall conductivity. Due to the absence of the pore-fluid conductivity data, this makes it difficult to ascertain the relative permeability of this sealant compared to the other sealants. Lastly, the higher conductivity of Sealant S4 indicates that it is more permeable than the OPC-based sealants.

Figure 22. Post-curing Conductivity plots of Sealants S1-S5.

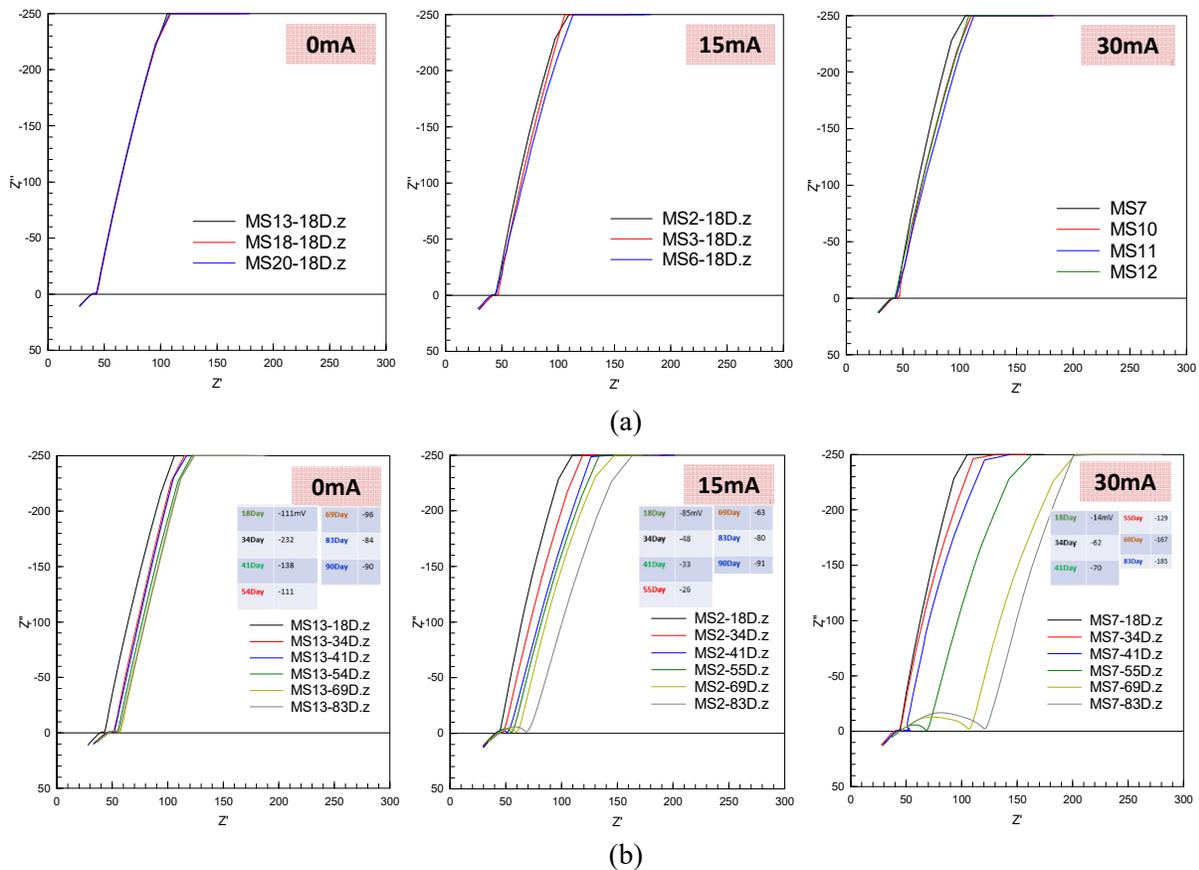
Figures 23(a) and (b) illustrate the impedance response measured across all LabCorr samples over the frequency range of 1Hz to 10MHz. The Plots shown in **Figure 23(a)** represent the response obtained 18 days after casting before the application of current, whereas the Plots shown in **Figure 23(b)** correspond to the response from 18 days to 83 days, with the current being activated from Day 26 onwards. It should be noted that in these plots, no nulling of lead-inductive effects has been performed over the full frequency range. As can be seen from **Figure 23(a)** that all samples exhibit a comparable response, characterised by a spur at the low-frequency end of the curve (forming part of a larger arc) and a bulk response at the high-frequency end. The spur represents the behaviour at the sample/sealant interface,

which is of particular interest. At this stage, there is no evidence of any additional polarising layer effect at the low-frequency end due to exposure to corrosion.

Regarding the Plots shown in **Figure 23(b)**, it is evident that for samples exposed to zero current (left-hand-side plot), the impedance spectra showed a consistent shift to the right, suggesting continued hydration. No significant alterations to the spur at the low-frequency end of the curve were observed. In samples subjected to a 15mA current (middle plot), a similar trend is evident, although there are noticeable changes in the radius of the spur at the low-frequency side of the curve, which may indicate corrosion occurring at the sample/sealant interface. For samples exposed to a current of 30mA, a more significant to the right is observed, suggesting that prolonged exposure to the current influences not only the sample/casing interface but also accelerates the cement hydration process. This could account for the previously observed increase in apparent bond strength, see **Figure 13**.

Figure 23. Impedance response for (a) Day 18 and (b) Days 18 – 83 (no nulling).

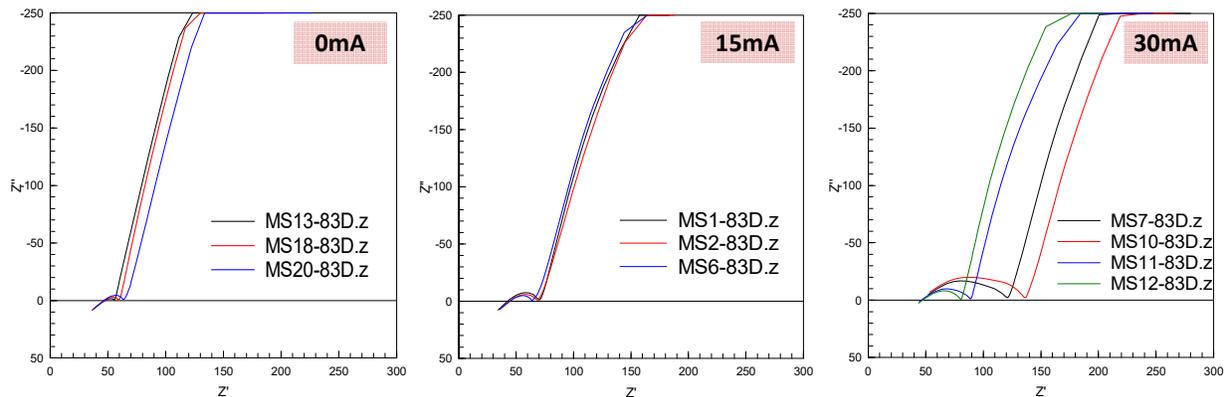
Figure 24 presents the impedance response for all samples tested on Day 83. It is apparent that prolonged exposure to corrosion has significantly influenced the overall response. Notably, the samples subjected to the high current of 30mA show a considerably wider variation in their impedance spectra compared to those exposed to lower current levels or no current at all. This increase in variations may be attributed to the inherently variable nature of corrosion processes. Post-testing sample extraction showed that the corrosion tends to progress more unevenly, leading to greater variations in the degree and distribution of corrosion across the samples (see **Figure 13**).

Figure 24. Impedance response for Day 83 for all test samples (no nulling).

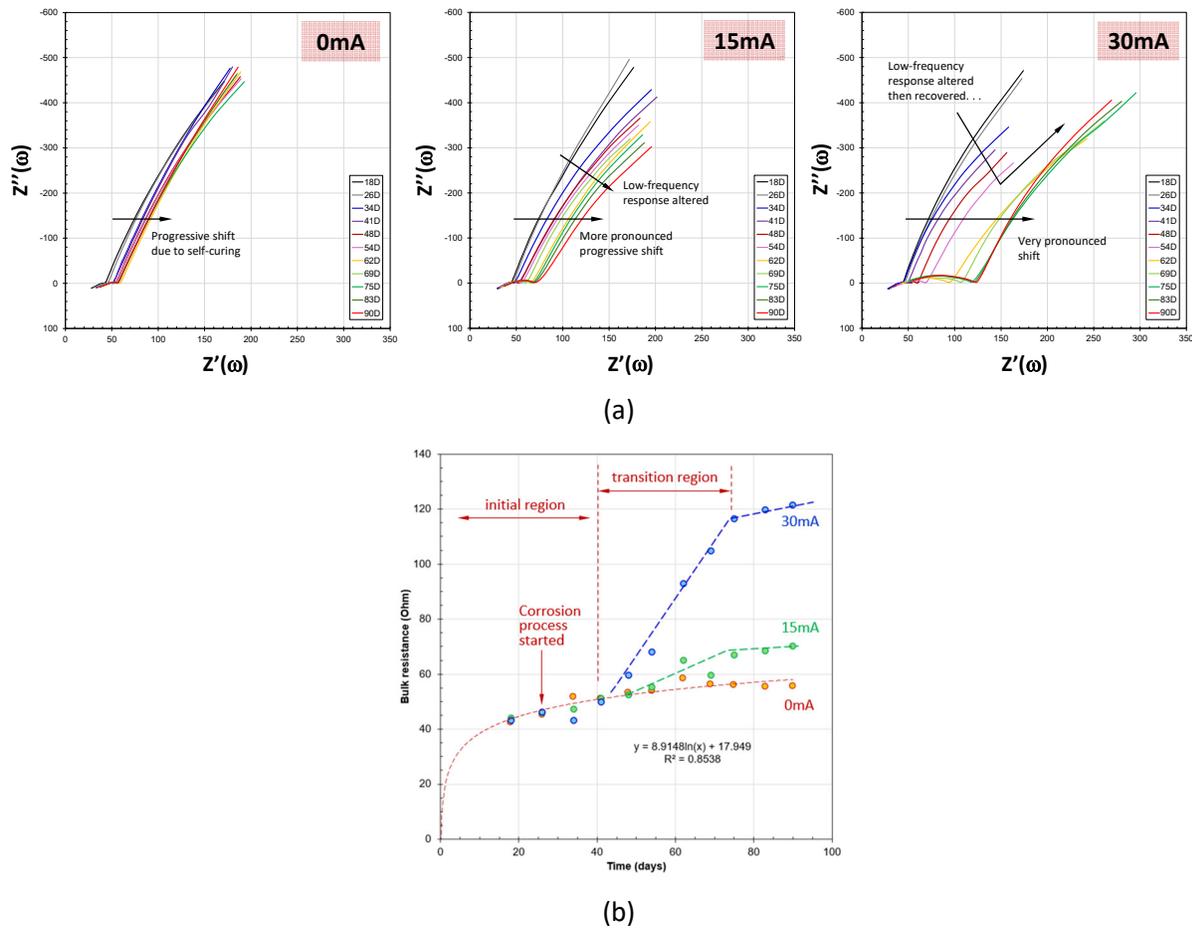
To obtain a better understanding of the influence of prolonged exposure to corrosion, **Figure 25(a)** illustrates the response of three individual sample exposed to no current, 15mA, and 30mA current levels throughout the entire exposure period, with a summary of the bulk resistance for the three representative samples presented in **Figure 25(b)**. As previously mentioned, the applied current levels correspond to current densities of 0, 0.21, and 0.42 mA/cm², respectively. The results show that all samples exhibited distinct responses depending on the current level applied. The low-frequency region of the curve forms part of a much larger arc and represents the response primarily at the sample/sealant interface and is therefore of particular interest. All samples displayed a progressive shift to the right-hand side of the curve, which can be attributed to the self-curing of the sealant. For samples subjected to prolonged exposure to electrical currents, a much more pronounced shift was observed, potentially attributed to additional curing effects caused by the application of electrical current, which is required to drive the corrosion process. In general, three distinct stages of response were observed: (i) an initial region of increasing resistance due to curing, (ii) a transitional region where resistance increased further, likely due to a combination of additional curing effects and corrosion at the steel casing/sealant interface, and (iii)

a final region where resistance continued to increase, driven primarily by further curing effects and likely corrosion at the interface. The observed increase in bulk resistance would suggest that the application of electrical current must have enhanced cement hydration, which may have contributed in part to the previously observed increase in apparent bond strength (see Figure 13).

Figure 25. Influence of exposure to prolonged corrosion on impedance and bulk resistance.

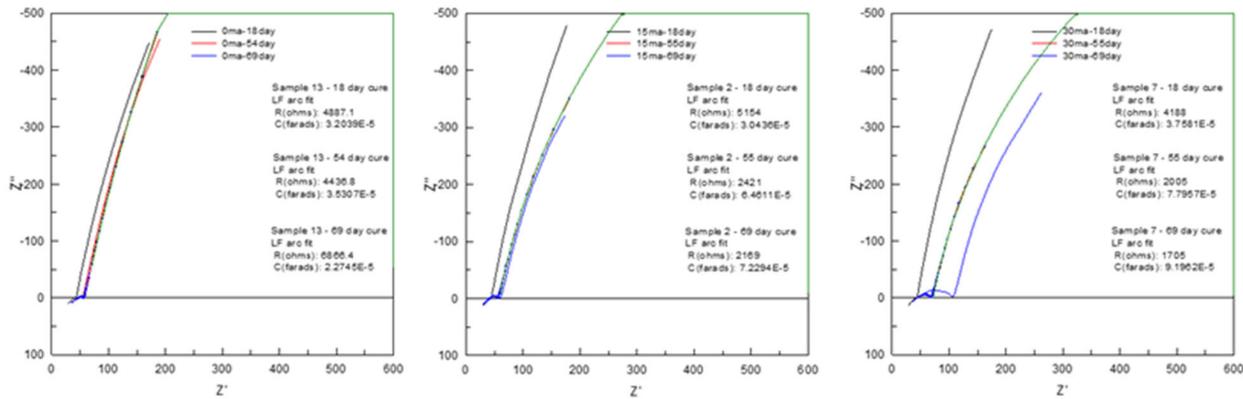
In addition to influencing the resistive component, corrosion at the steel casing/sealant interface is anticipated to introduce capacitive effects to the overall system. This is attributed to the development of corrosion products at the sealant/steel interface, which possess distinct properties that can alter the electrical characteristics of the system. To investigate this phenomenon, electrical circuit analysis was performed by modelling the low-frequency portion of the impedance spectra using an equivalent circuit comprising a resistor and capacitor connected in parallel. The low-frequency range was deliberately selected, as this region effectively captures the behaviour at the sealant/steel casing interface, where the

effect of corrosion is expected to be the most prominent. An example of the circuit parameters obtained from this analysis is shown in **Figure 26(a)**. As can be seen, both the resistive and capacitive components of the equivalent circuit were influenced by the prolonged induced corrosion, indicating that corrosion at the sealant/casing interface not only alters the interface characteristics but also impacts the overall response.

Figure 26. Equivalent circuit modelling on the low-frequency response.

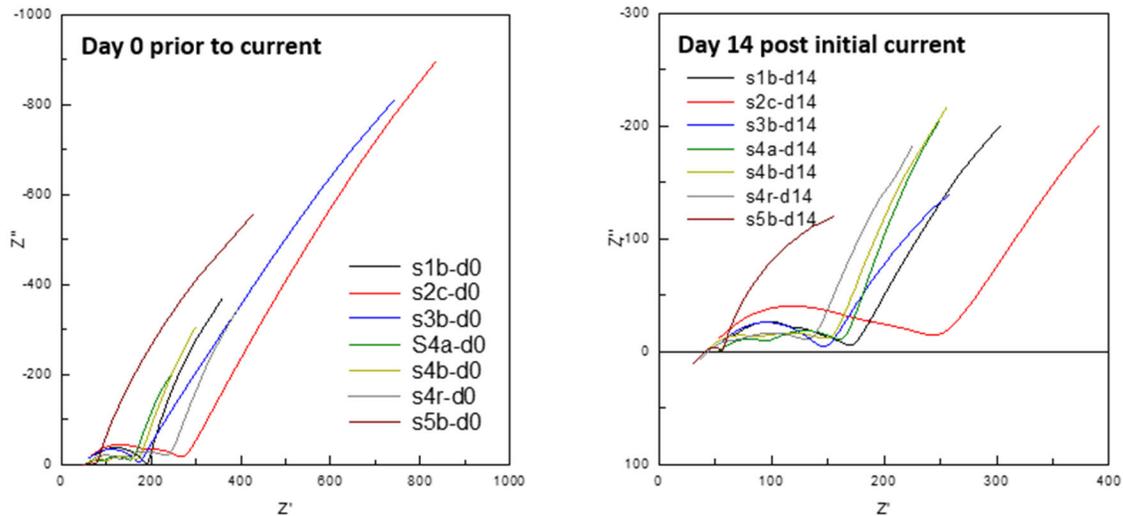
Figure 27 displays the impedance response of autoclave-cured Sealant S1-S5 samples subjected to both high-temperature curing and corrosion regimes. Based on earlier measurements, the current was initially set at 30mA. However, after 2 days, this was further reduced to 20mA and subsequently switched off after 7 days, as the voltage in several samples approached the upper limit of the power supply. This would suggest that high-temperature exposure significantly increased the likelihood of corrosion initiation, with the rapid increase in voltages suggesting that corrosion progresses more rapidly at the sealant/casing interface than the lab-cured samples. The current application was then resumed at 5mA starting from Day 14. From **Figure 27**, it is interesting to note that all sealants produce a significantly different impedance response at the beginning of testing (Day 0). The impedance spectra of the sealants at Day 14, post initial corrosion regime, are comparable to those measured at the start of experiment (prior to current application), particularly on the shape and extent of the high-frequency bulk arc. This would indicate that there was virtually no additional curing and could be associated with the fact that this series of samples was subjected to the enhanced curing regime (elevated temperature and pressure). It is however interesting to note that the spur at the low-frequency end showed notable changes, which is generally much shorter.

Figure 27. Impedance response of Sealants S1-S5 before and after exposure.

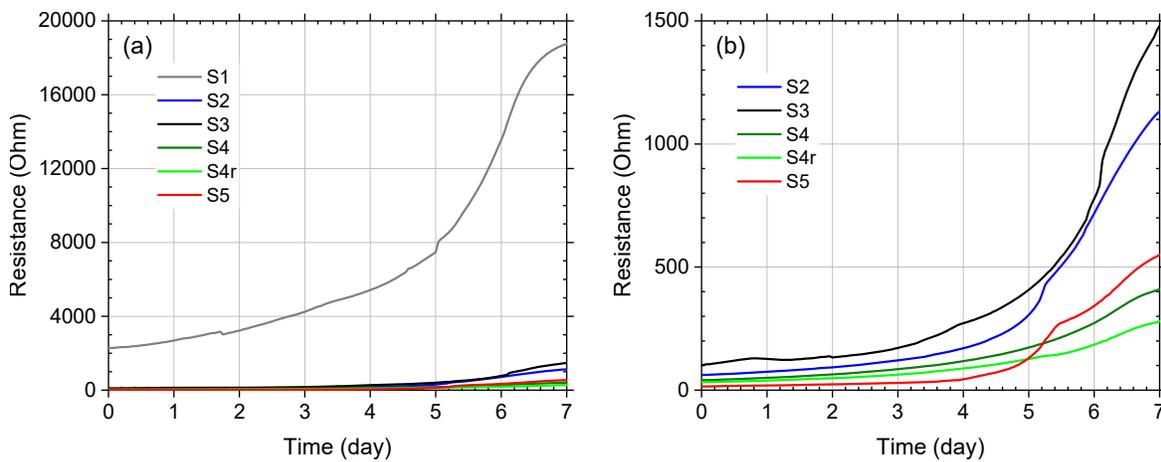
Figure 28. Resistance of Sealants S1-S5 measured over a temperature range of 20-150°C within a 7-day period.

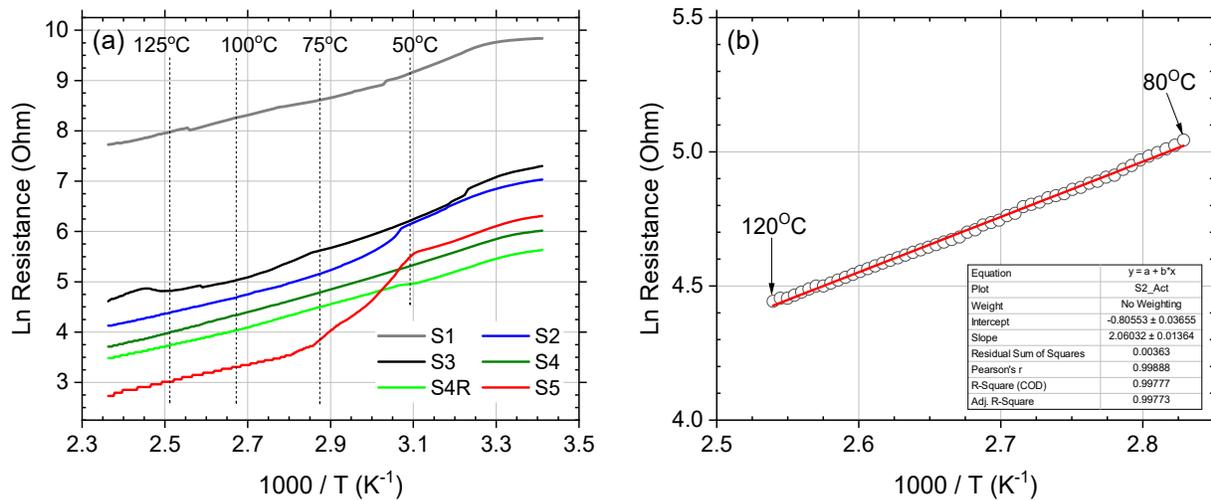
Figure 29 (a) presents the plots of the natural logarithm of bulk Resistance ($\ln R$) for each sealant plotted as a function of $1000/T$. It is interesting to note that the highly nonlinear curves observed earlier have transitioned into less nonlinear response, with a linear relationship emerging over certain temperature ranges. Interestingly, Sealants S4 and S4R display a predominantly linear response across the entire temperature range $150^\circ\text{C} \rightarrow 20^\circ\text{C}$. Building upon the linearity of Equation (3), determining the slope of each curve over a certain temperature range can provide useful information. The slope can subsequently be multiplied by R_g to calculate the activation energy, expressed in kJ/mol. The activation energy, in this context, can be interpreted as the energy barrier that ions must overcome to enable conduction within the pore network. Hence this parameter offers valuable insights into the pore connectivity of the individual sealants. A constant activation energy across a certain temperature range would indicate that

ionic conduction through the pore network is the prevailing mechanism, with no physical alterations in the connectivity of the pore structure. To this end, the activation energy was evaluated between 80°C and 120°C, corresponding to the typical operational temperature of a well. **Figure 29 (b)** provides an example for Sealant S2, with the data point fitted using a linear equation. The activation energy values recorded for all sealants within this temperature range were largely comparable: 16.73 kJ/mol, 17.13 kJ/mol, 17.03 kJ/mol, 17.39 kJ/mol, and 14.30 kJ/mol for Sealants S1 through S5, respectively. Sealant S5 displayed a notably lower value, which could be attributed to its higher ionic content. Notably, there are specific temperature ranges below 80°C where an increase in slope is evident as temperature decreases. Although this temperature range currently falls outside the primary area of interest at present, this approach could be further explored to assess how pore connectivity for a particular sealant changes with variations in temperature.

Figure 29. Arrhenius plots for: (a) Sealants S1-S5 over the temperature range 20-150°C and (b) Sealant S2 over the temperature range 80-120°C.

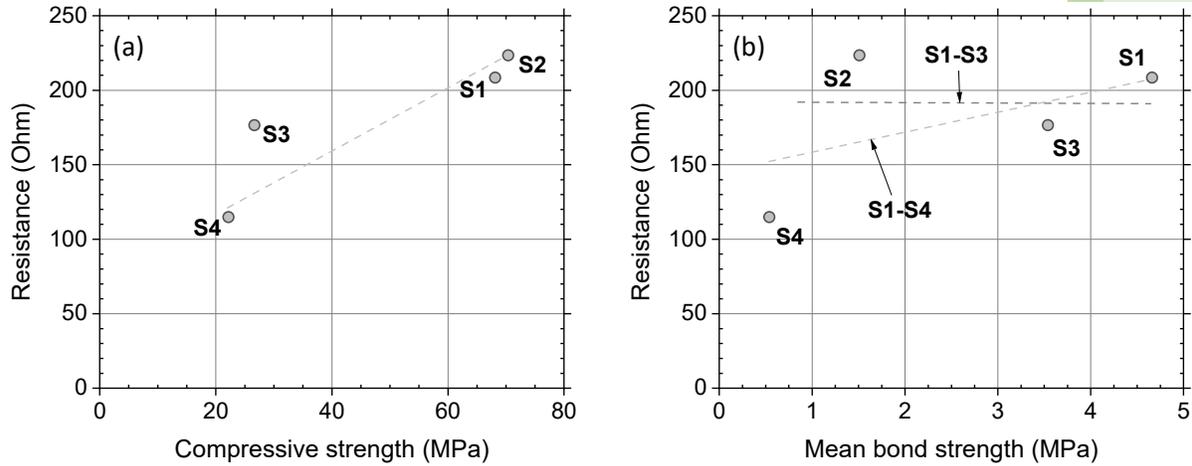
Figures 30(a) and **(b)** illustrate the observed relationships between the evaluated parameters between the mechanical properties obtained from shear-bond testing and electrical measurements. With reference to **Figure 30(a)**, there appears to be a notable correlation between bulk resistance and compressive strength, which is somewhat unexpected. Bulk resistance typically indicates the level of connected porosity within the sealant, while compressive strength is indicative of the overall structural integrity of the pore network. The apparent correlation between these parameters is interesting and warrants further investigation. In contrast, as shown in **Figure 30(b)**, the comparison between bulk resistance and mean bond strength reveals only a weak correlation. It is important to highlight that Sealant S4 experienced premature failure, which could have skewed the perceived trend. When the analysis is restricted to Sealants S1 to S3, the relationship between bulk resistance and mean bond strength seems to flatten, presenting a horizontal trend. This would indicate that there is little to no correlation between these two parameters. The lack of correlation can be attributed to the different characteristics these parameters represent. Bulk resistance measures the overall bulk properties of the material, such as its porosity and connected pathways. On the other hand, mean bond strength is primarily determined by the interfacial properties at the sealant/casing interface. This distinction emphasises that the mean bond strength cannot be estimated from the bulk resistance.

Figure 30. Comparisons of bulk resistance with measured compressive and mean bond strengths.

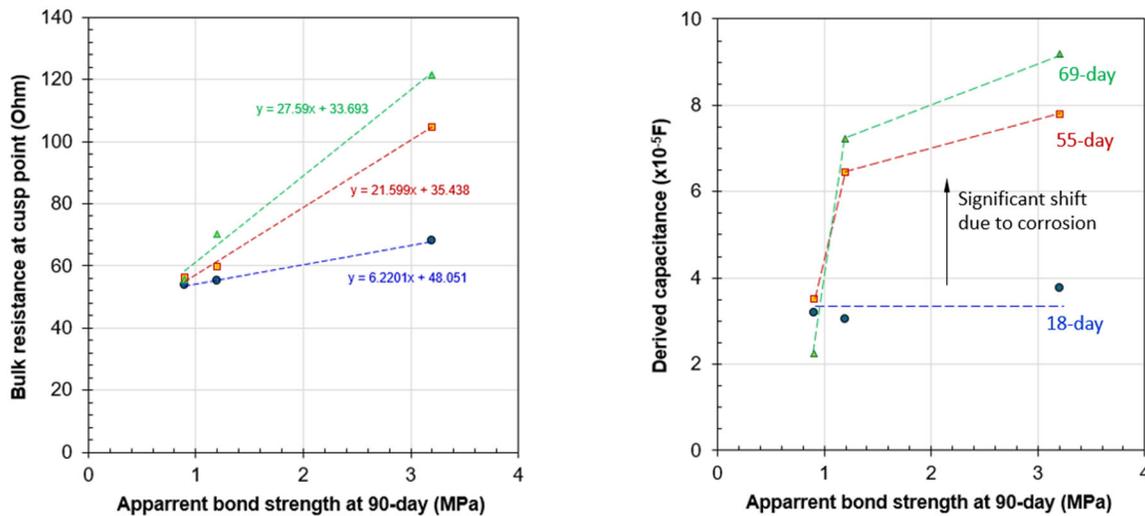
The correlation between the parameters obtained from the equivalent circuit modelling and mean bond strength is presented in **Figures 31 (a)** and **(b)** for samples subjected to no current, 15mA, and 30mA (current densities of 0, 0.21, and 0.42 mA/cm², respectively). Overall, it was found that the application of the electrical current not only facilitates corrosion at the sealant/sample interface but also influences the hydration and curing processes. As can be seen from **Figure 31 (a)** that there is a strong correlation between bulk resistance and the mean bond strength, and this could be attributed to the additional curing effects caused by the application of electrical current, which is required to drive the corrosion process discussed above. Interestingly, the data also show a substantial increase in the capacitive component when correlated with the mean bond strength across the various samples. This observation suggests that the capacitive behaviour may serve as a valuable indicator for monitoring the likelihood of corrosion initiation at the sealant/casing interface. The capacitive component, reflective of the changes occurring at the interface, provides further insight into the effects of corrosion and could have broader implications for detecting corrosion initiation at the sealant/casing interface.

Figure 31. Comparisons of bulk electrical properties and mean bond strength after exposure.

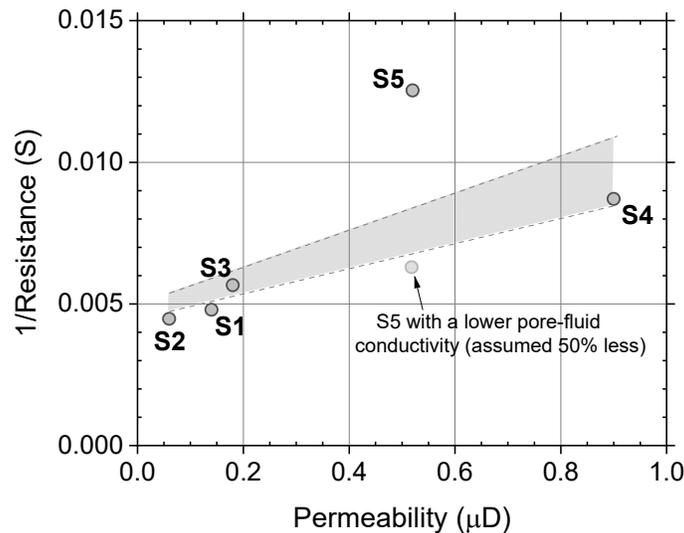
Overall, **Figure 32** displays that there is a somewhat correlation between conductance and permeability, with the conductivity increasing with increasing permeability as one would expect. Interestingly, Sealant S4 demonstrates relatively low conductance in relation to its permeability, potentially due to a lower ionic strength in the pore fluid. Conversely, Sealant S5 exhibits comparatively high conductivity relative to its permeability, which may indicate that its pore-fluid conductivity might be much higher than that of the PC-based materials (i.e., Sealants S1–S3). From the spread of the data, it appears that the pore fluid conductivity in this sealant is approximately twice that of the PC-based sealants, which broadly aligns with findings reported in published literature. The findings presented suggest that electrical measurements could offer a means of evaluating seal permeability, provided those factors influencing electrical impedance, such as pore fluid composition, are properly accounted for.

Figure 32. Comparisons of bulk conductance and material permeability.
