## 1997 Mazda MX-5 Miata

1997 AUTOMATIC TRANSMISSIONS NC4A-EL Electronic Controls

#### NC4A-EL Electronic Controls

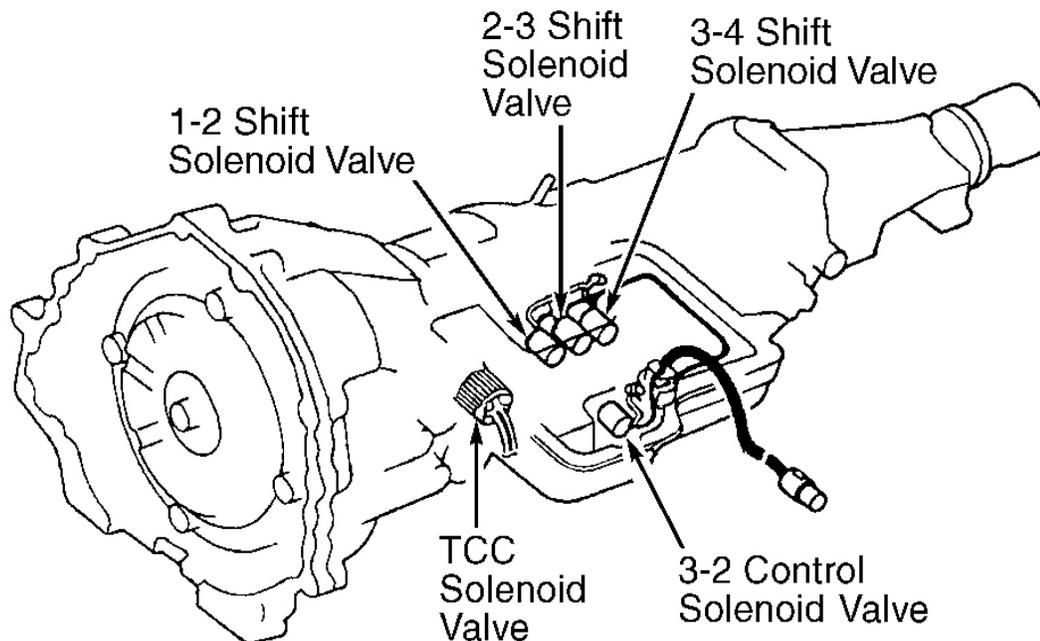
96J30840

**Fig. 1: Locating Solenoid Valves**  
 Courtesy of MAZDA MOTORS CORP.

The TCM controls transmission shifting by delivering an output signal to operate proper solenoid. 3-2 control solenoid affects downshift timing. See **SOLENOID OPERATION** table. Hydraulic pressure is retained when solenoid is off and drained when solenoid is on. Solenoids are located on transmission valve body. See **Fig. 1**.

Solenoid valve is ON/OFF type controlled by TCM. Solenoid regulates pilot pressure to applied to lock-up control plug. Hydraulic pressure is retained when solenoid is on and drained when solenoid is off. Solenoid is located on side of case. See **Fig. 1**.

<b>Description</b>	<b>Location</b>
Engine Control Module	Behind Passenger Seat
Input/Turbine Speed Sensor	Mounted To 4th Gear Case
Shift Solenoids	See <b>Fig. 1</b>
TCC Lock-Up Solenoid	See <b>Fig. 1</b>
Transmission Control Unit	Above Fuse Box
3-2 Control Valve	See <b>Fig. 1</b>
TFT Sensor	Mounted In-Line To Cooler Line
Vehicle Speed Sensor	Mounted In Speedometer

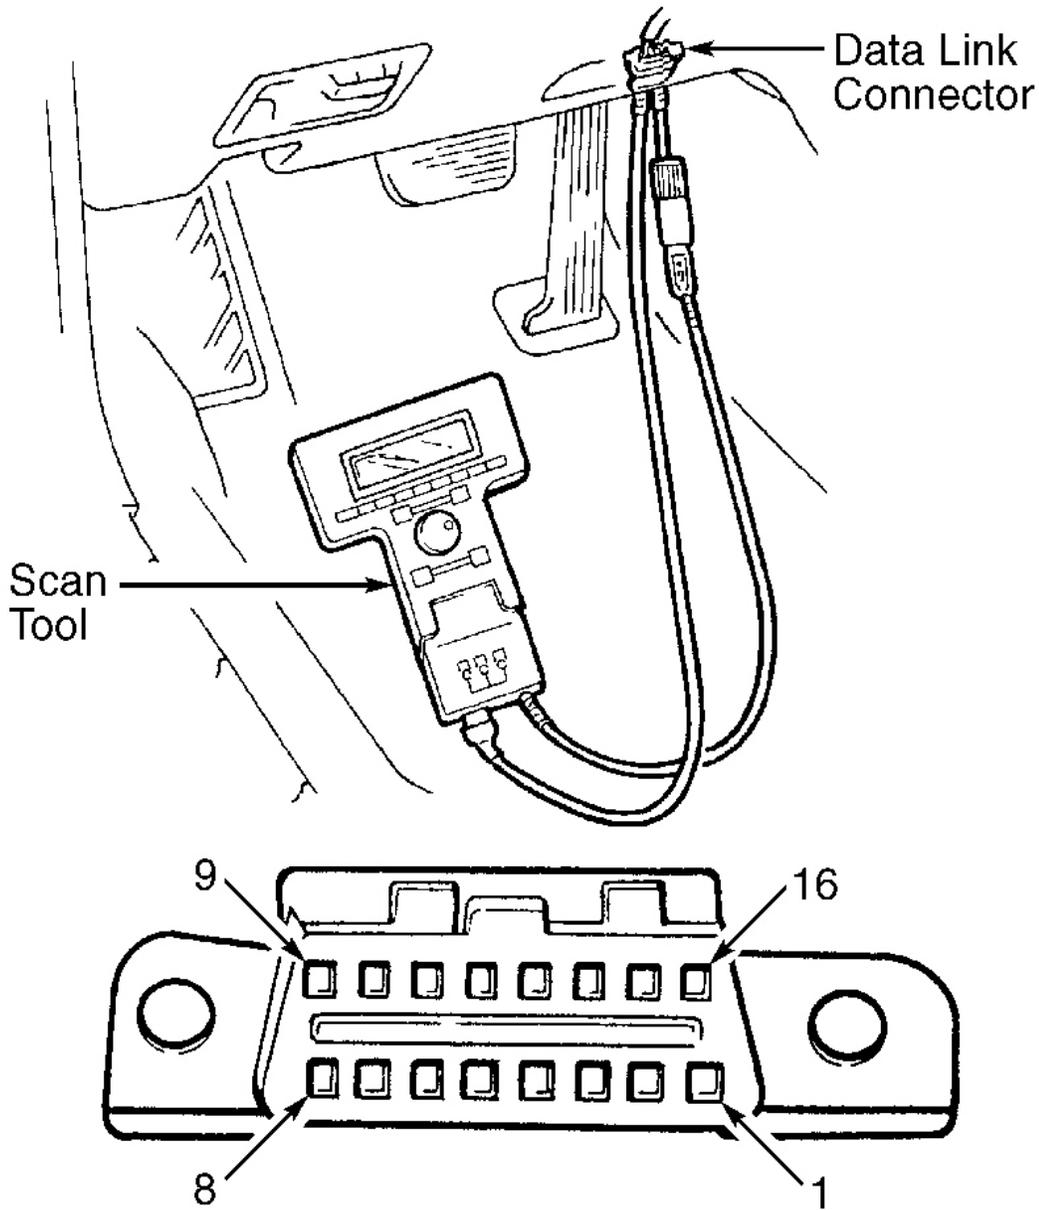
G96F19153

**Fig. 2: Locating Data Link Connector (DLC) Location**  
Courtesy of MAZDA MOTORS CORP.

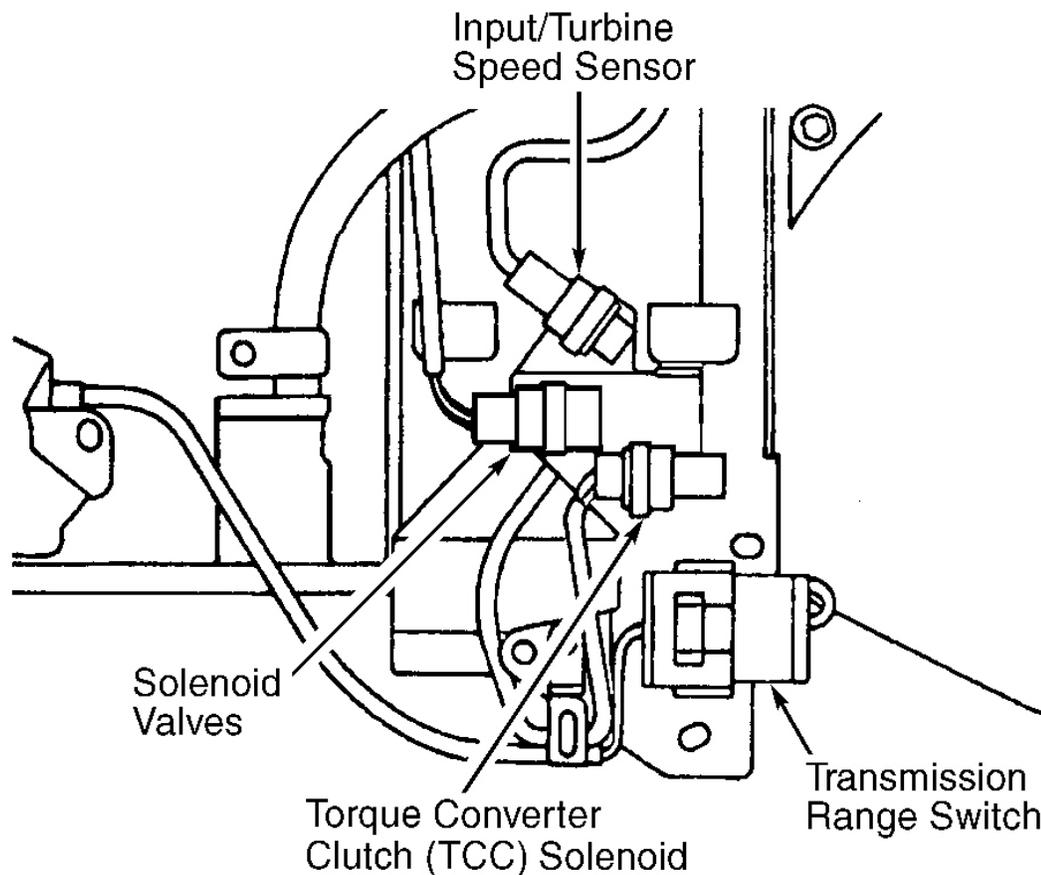
96E31603

**Fig. 3: Locating Transmission Component Connectors**

(1) For connector location see **Fig. 3** .

Disconnect output speed sensor connector. See **Fig. 3** . Measure resistance between terminals. Resistance should be 245 ohms. Replace as needed.

Disconnect negative battery cable. Disconnect transmission solenoid harness connector. See **Fig. 3** . Note that solenoids ground through transmission case. Check resistance between connector terminals and ground. See **Fig. 7** . Resistance should be 13-27 ohms. Replace solenoids as necessary. See **SOLENOID VALVE IDENTIFICATION** table. Ensure transmission case is grounded.

Disconnect negative battery cable. Disconnect TCC solenoid harness connector. See **Fig. 3** . Check resistance

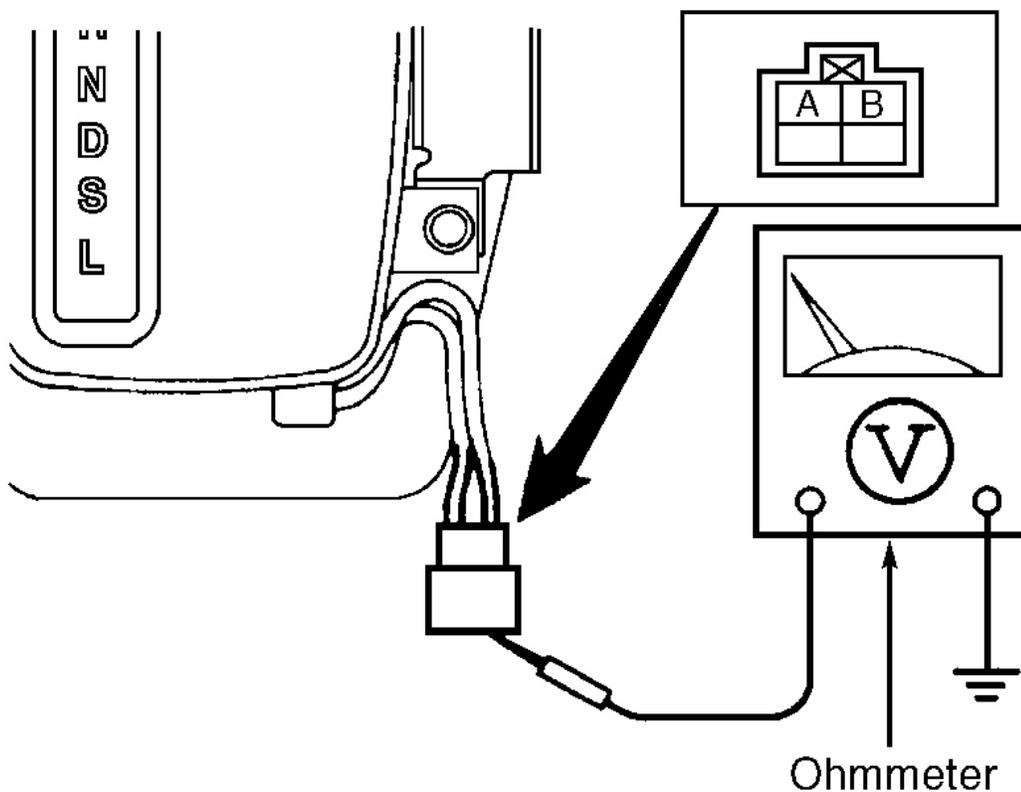
96H31606

1. Turn ignition on. Ensure HOLD indicator illuminates with switch depressed. Ensure indicator light is not illuminated when switch is released. If switch is not working as described, go to next step.
2. Access switch connector under center console. Disconnect connector. Check continuity between terminals "A" and "B". See **Fig. 6** . Continuity should exist when switch is depressed. When switch is released, continuity should not exist. Replace as needed. If HOLD switch system does not function correctly, inspect circuits between switch and TCM. See appropriate wiring diagram in **WIRING DIAGRAMS** .

**Fig. 6: Testing HOLD Switch**  
 Courtesy of MAZDA MOTORS CORP.

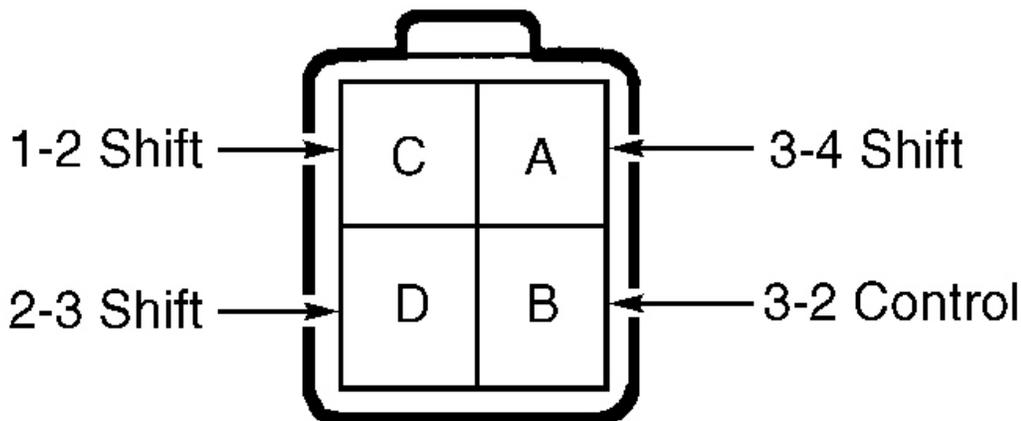
96D31602

**Fig. 7: Identifying Solenoid Valve Terminals**  
 Courtesy of MAZDA MOTORS CORP.

(1) See **Fig. 7** for terminal identification.

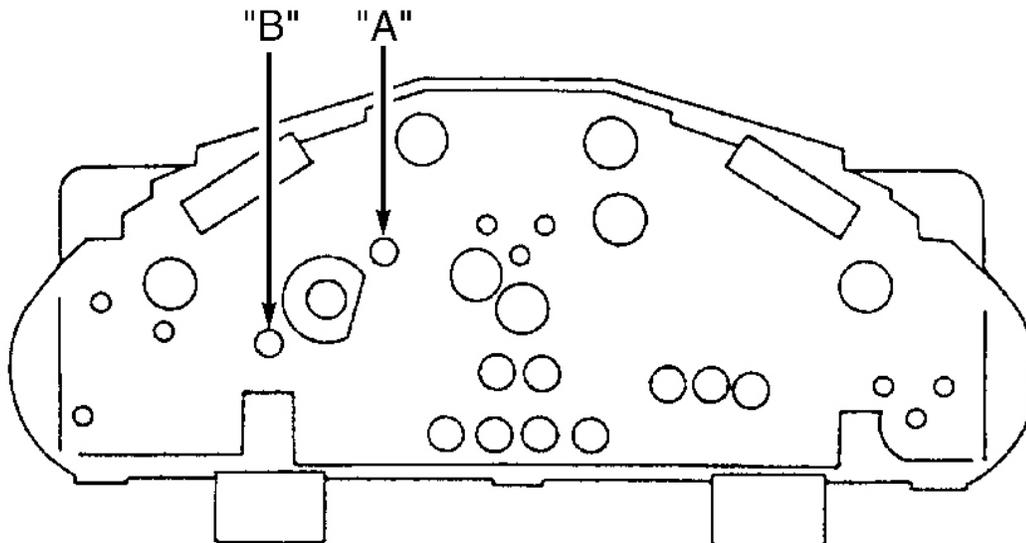
97A11650

**Fig. 8: Testing Vehicle Speed Sensor**  
 Courtesy of MAZDA MOTORS CORP.

Disconnect negative battery cable. Remove combination meter. Disconnect harness connectors and speedometer cable. Connect analog voltmeter leads to meter terminals "A" and "B". See **Fig. 8** . Using appropriate screwdriver, rotate speedometer cable shaft. If voltmeter needle does not fluctuate, replace sensor.

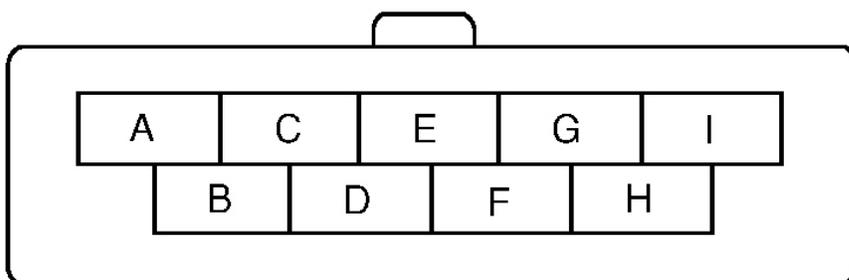
COMPONENT CONNECTOR

Position/ Range	Connector Terminal								
	A	B	C	D	E	F	G	H	I
P		○			○			○	○
R							○		○
N		○		○				○	○
D			○						○
S						○			○
L	○								○

1. Check for starter operation with ignition switch in START position and selector lever in "P" and "N" position only. Ensure back-up lights illuminate with ignition in ON position and selector lever in "R" position. If any problems are found, go to next step.
2. Disconnect transmission range switch connector. See **Fig. 3** . Check continuity between specified terminals. See **Fig. 9** . If continuity is not as specified, replace switch.
