Bonding performance of cement sealants designed for CCS applications

CEMENTEGRITY Deliverables 5.1 – 5.4 Published 2025-03-28

Keywords: CCS, cement plug, bond integrity, interface condition.

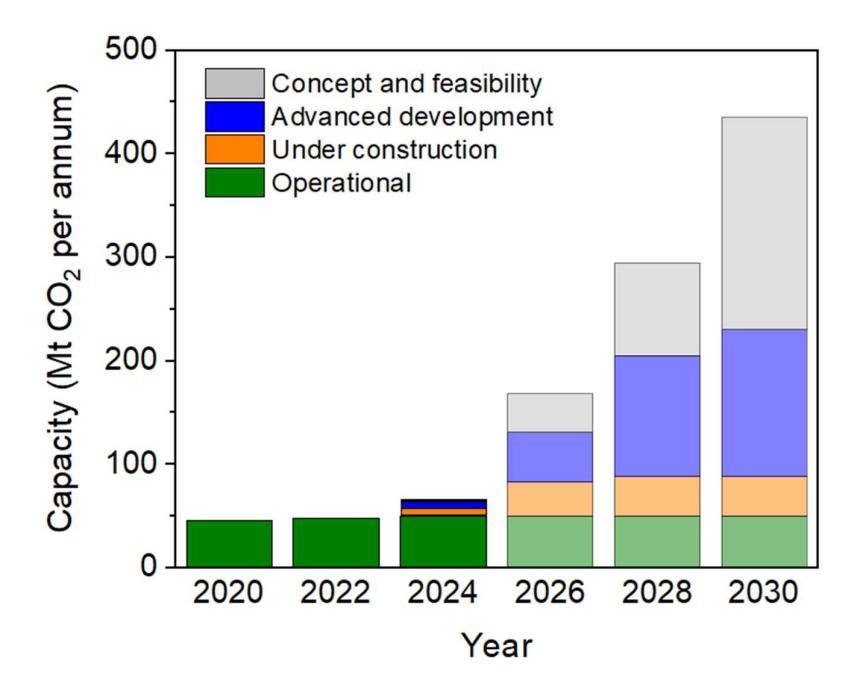
Figure 1. Historical (dark colour) and projected (transparent colour) global large-scale CCS capacity

according to the International Energy Agency [1].

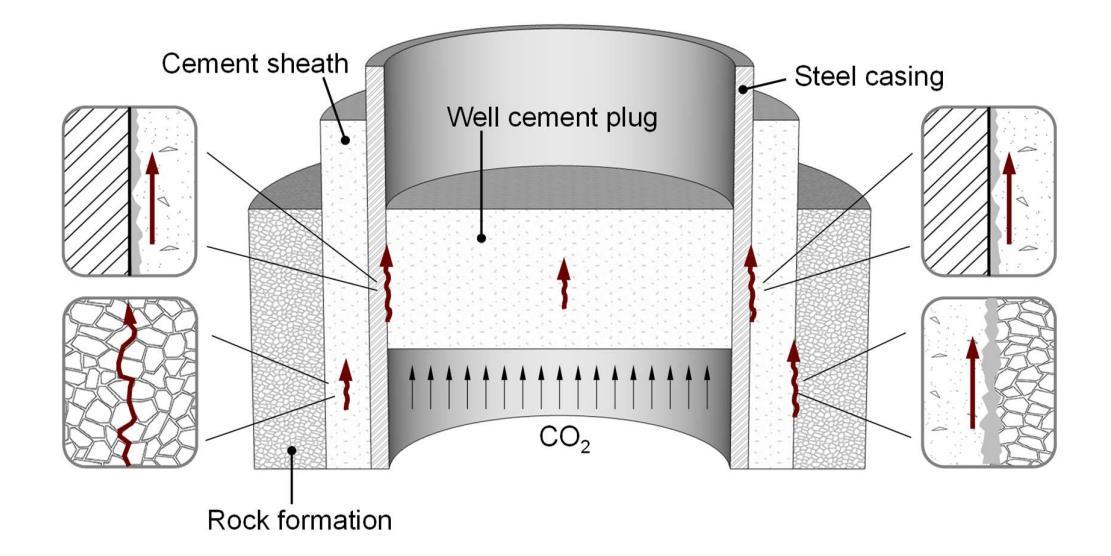
Figure 2. Schematic representation of possible leakage pathways in a CCS well: (i) through direct permeation or internal fractures within the well cement plug and/or cement sheath; (ii) through the interface between the inner or outer surfaces of the wellbore casing; and (iii) through the interface between cement sheath and rock formations.

Given the projected timescales envisaged in the operation of CCS storage facilities (well in excess of the lifespan of traditional oil and gas wells), minimising the leakage rate of CO_2 is of utmost importance for effective performance [4]. As shown schematically in **Figure 2**, there are a number of potential leakage pathways that need to be addressed. Such pathways include leakage through the cement plug itself either via direct permeation or internal fractures, through the external/internal surface of the wellbore casing, through cement sheath around the well, or through the interface between cement sheath and surrounding rock formations.

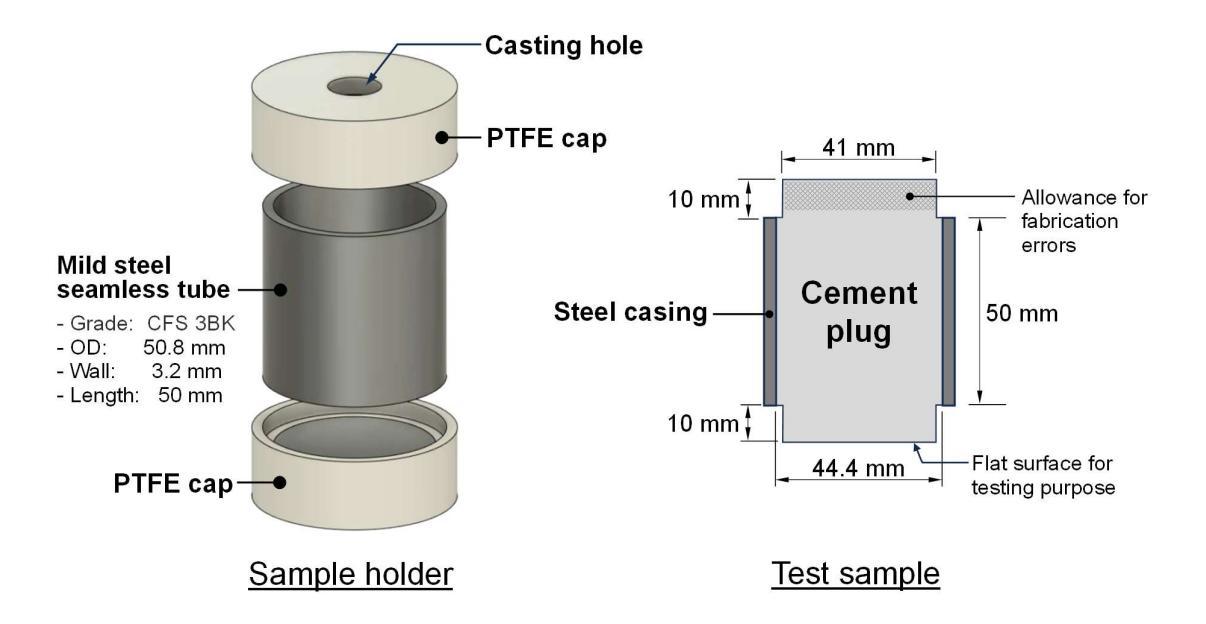
Figure 3. Schematic of test sample representing a miniature of a plugged wellbore.

The test sample for the bond test took the form of miniature versions of a plugged wellbore, comprising an outer cylindrical steel casing and an internal cement plug (see the schematic diagram in **Figure 3**). The steel casing had a length of 50 mm, an outside diameter of 50.8 mm, and a wall thickness of 3.2 mm. The use of mild steel casing (Grade CFS 3BK) instead of super duplex steel (used typically for CCS well) was sought by the project consortium at the onset of the project to allow for possible occurrence of corrosion to take place (thereby simulating long-term operation), in addition to facilitate the machining of the two ends of the casing.

The internal sealant cement plug had a diameter of approximately 44.4 mm and a 10 mm protruding end on either side, which had a diameter of 41 mm. These protruding ends were provided to minimise the boundary effects during mechanical bond testing: the top part was provided to remove the undesirable effects from the presence of relatively poor quality of material and uneven surface at the top during sample preparation, whereas the bottom part was to minimise the effect of high concentration of stresses under the loading plate during testing. The manufacture of this protruding shape was

facilitated by two PTFE end caps which encapsulated the sealant during sample fabrication and curing. The top PTFE cap had a 20 mm central hole for casting purpose, while the bottom cap was fitted without any alteration to provide a flat surface for bond testing.

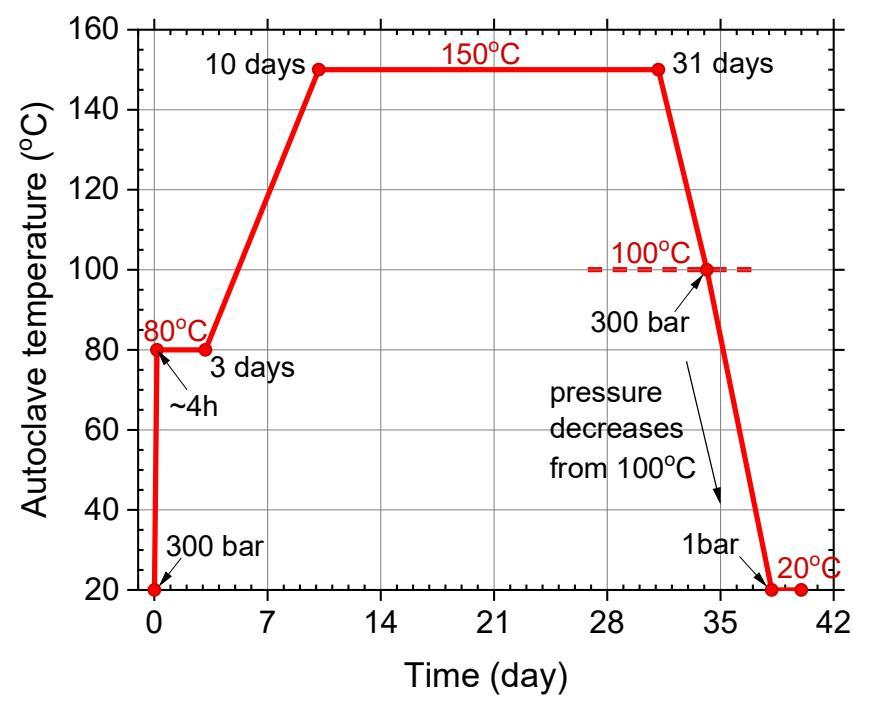
Figure 4. Curing regime adopted in the experimental programme.

For each sealant, casting was done by syringing fresh slurry into a 20 mm hole on the top cap, which was then sealed using a 3D-printed plastic cap. All samples were subsequently stacked inside a stainless-steel autoclave chamber. As illustrated in **Figure 4**, the following curing regime was adopted:

- (i) The internal pressure was first increased to 300 bars
- (ii) The internal temperature was then raised from ~20 to 80°C over a period of 4 hours
- (iii) The internal temperature was held at 80°C for 3 days before being raised again to 150°C over 7 days before being held constant at 150°C for a further 21 days

(iv) The internal temperature was lowered from 150°C to 20°C over a period of 7 days. During this stage, the internal pressure regulator was released when the temperature reached 100°C to allow for the chamber to reach equilibrium depending on the temperature level.

Stage (ii) was considered to simulate general cementing, where cement slurry is typically injected into a wellbore typically at ambient (low) temperatures. The temperature of the slurry can be expected to increase at greater depths, eventually reaching equilibrium with the temperature of the surrounding rock formations, which, for a 2 to 3 km deep offshore reservoir, could range from 80°C to 120°C [15,16]. The 80°C temperature was selected in this work based on the minimum CCS operational temperature and practicality during bond testing.

The high-temperature curing employed in Stage (iii) (i.e., 150°C) was intended to enable the sealants to achieve near or full hydration within a reasonable timeframe, thereby avoiding further changes in properties post curing. Subsequent electrical monitoring confirmed that maintaining 150°C over the 3-week duration was adequate. It should be noted that the internal autoclave temperature was gradually increased to 150°C and then steadily lowered back to 20°C, to minimise thermal effects on the interfacial bond during the heating and cooling stages. At the end of the curing regime, all samples were wrapped in wet clothes and airlifted back to the UK for subsequent bond testing. These samples were kept in a water bucket upon delivery and stored in a temperature-controlled laboratory (20±1°C) until required for testing.

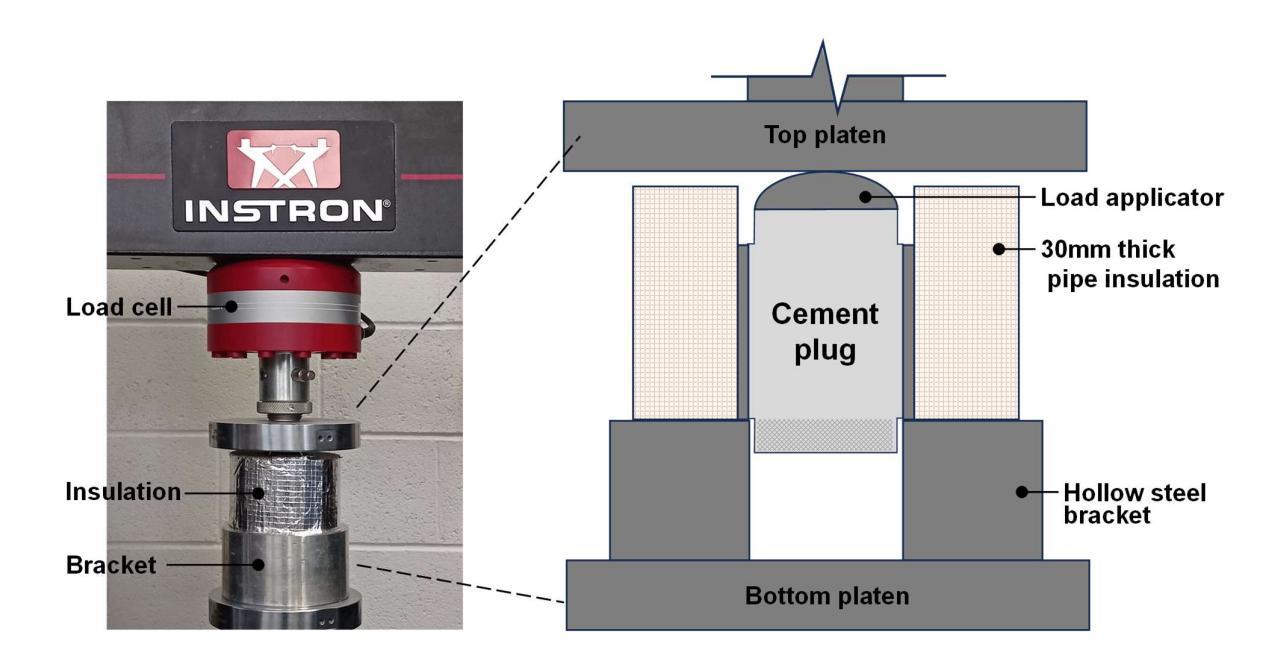
Figure 5. Schematic diagram of bond test.

to minimise temperature loss during bond testing. The sample was then placed on a central-hollow steel bracket (also pre-conditioned at 80°C) in an upside-down position to present the flat face of the sample to the loading plate on top. The load was then applied through a hemispherical steel plate placed on the top of the sealant in a force-controlled manner, at a rate of 5kN/min. The machine automatically stopped when a sudden drop of resistance (i.e., by more than 20%) occurred, due to either sliding or crushing of the inner cement plug.

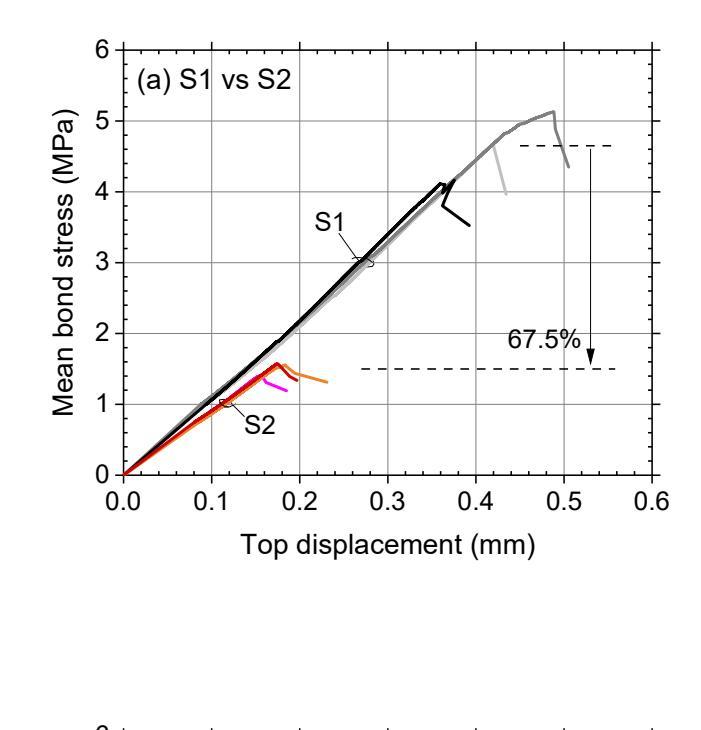
Figure 6. Mean bond stress-top displacement for the four sealants.

Figures 6(a)-(c) display the mean bond stress vs top displacement relationships for the four sealants, with each Figure comparing the results of three notionally identical samples for each sealant with those of Sealant S1. In general terms, all sealants displayed a similar increase in the mean bond stress with increasing displacement until failure, which occurred suddenly due to sliding of the sealant in the vertical direction. The individual sealants exhibited varying bond strengths and overall stiffnesses. For reasons of clarity, the mean apparent bond strength and stiffness, and their respective standard deviation (SD) and coefficient of variation (CoV), are presented in **Table 3** for the four sealant types.

With reference to **Figures 6(a)-(c)**, a general reduction in the overall stiffness and bond strength is evident compared to those of Sealant S1, with both parameters decreasing in the order: S1 < S3 < S2 < S4. For instance, in case of Sealant S2, the mean bond strength and stiffness were 1.51 MPa and 8.95 N/mm³, which are only 32.5% and 80.6% of those of Sealant S1, respectively. Sealant S3 exhibited higher mean bond strength and stiffness, with mean values of 3.54 MPa and 9.20 N/mm³, corresponding

to 75.9% and 82.9% of those of the reference value, respectively. Sealant S4 demonstrated the lowest mean bond strength (= 0.54 MPa), which is only 11.5% of that of the reference sealant, and the lowest overall stiffness (= 2.88 N/mm³, or only 25.9% of that of Sealant S1). This might be attributed to sliding shear movement between the sealant and the steel casing during testing.

The overall stiffness of the curves presented in **Figures 6(a)-(c)** can primarily be attributed to the deformation of the top protruding part of each sample under loading and the initial slip between the sealant and the metal casing during bond testing, in addition to the deformation of the entire test setup,
